*WESTWOOD SEWER SYSTEM REHABILITATION FIGURES*

**FY19 SEWER SYSTEM REHABILITATION  
 WESTWOOD, MA  
 LOCUS MAP**

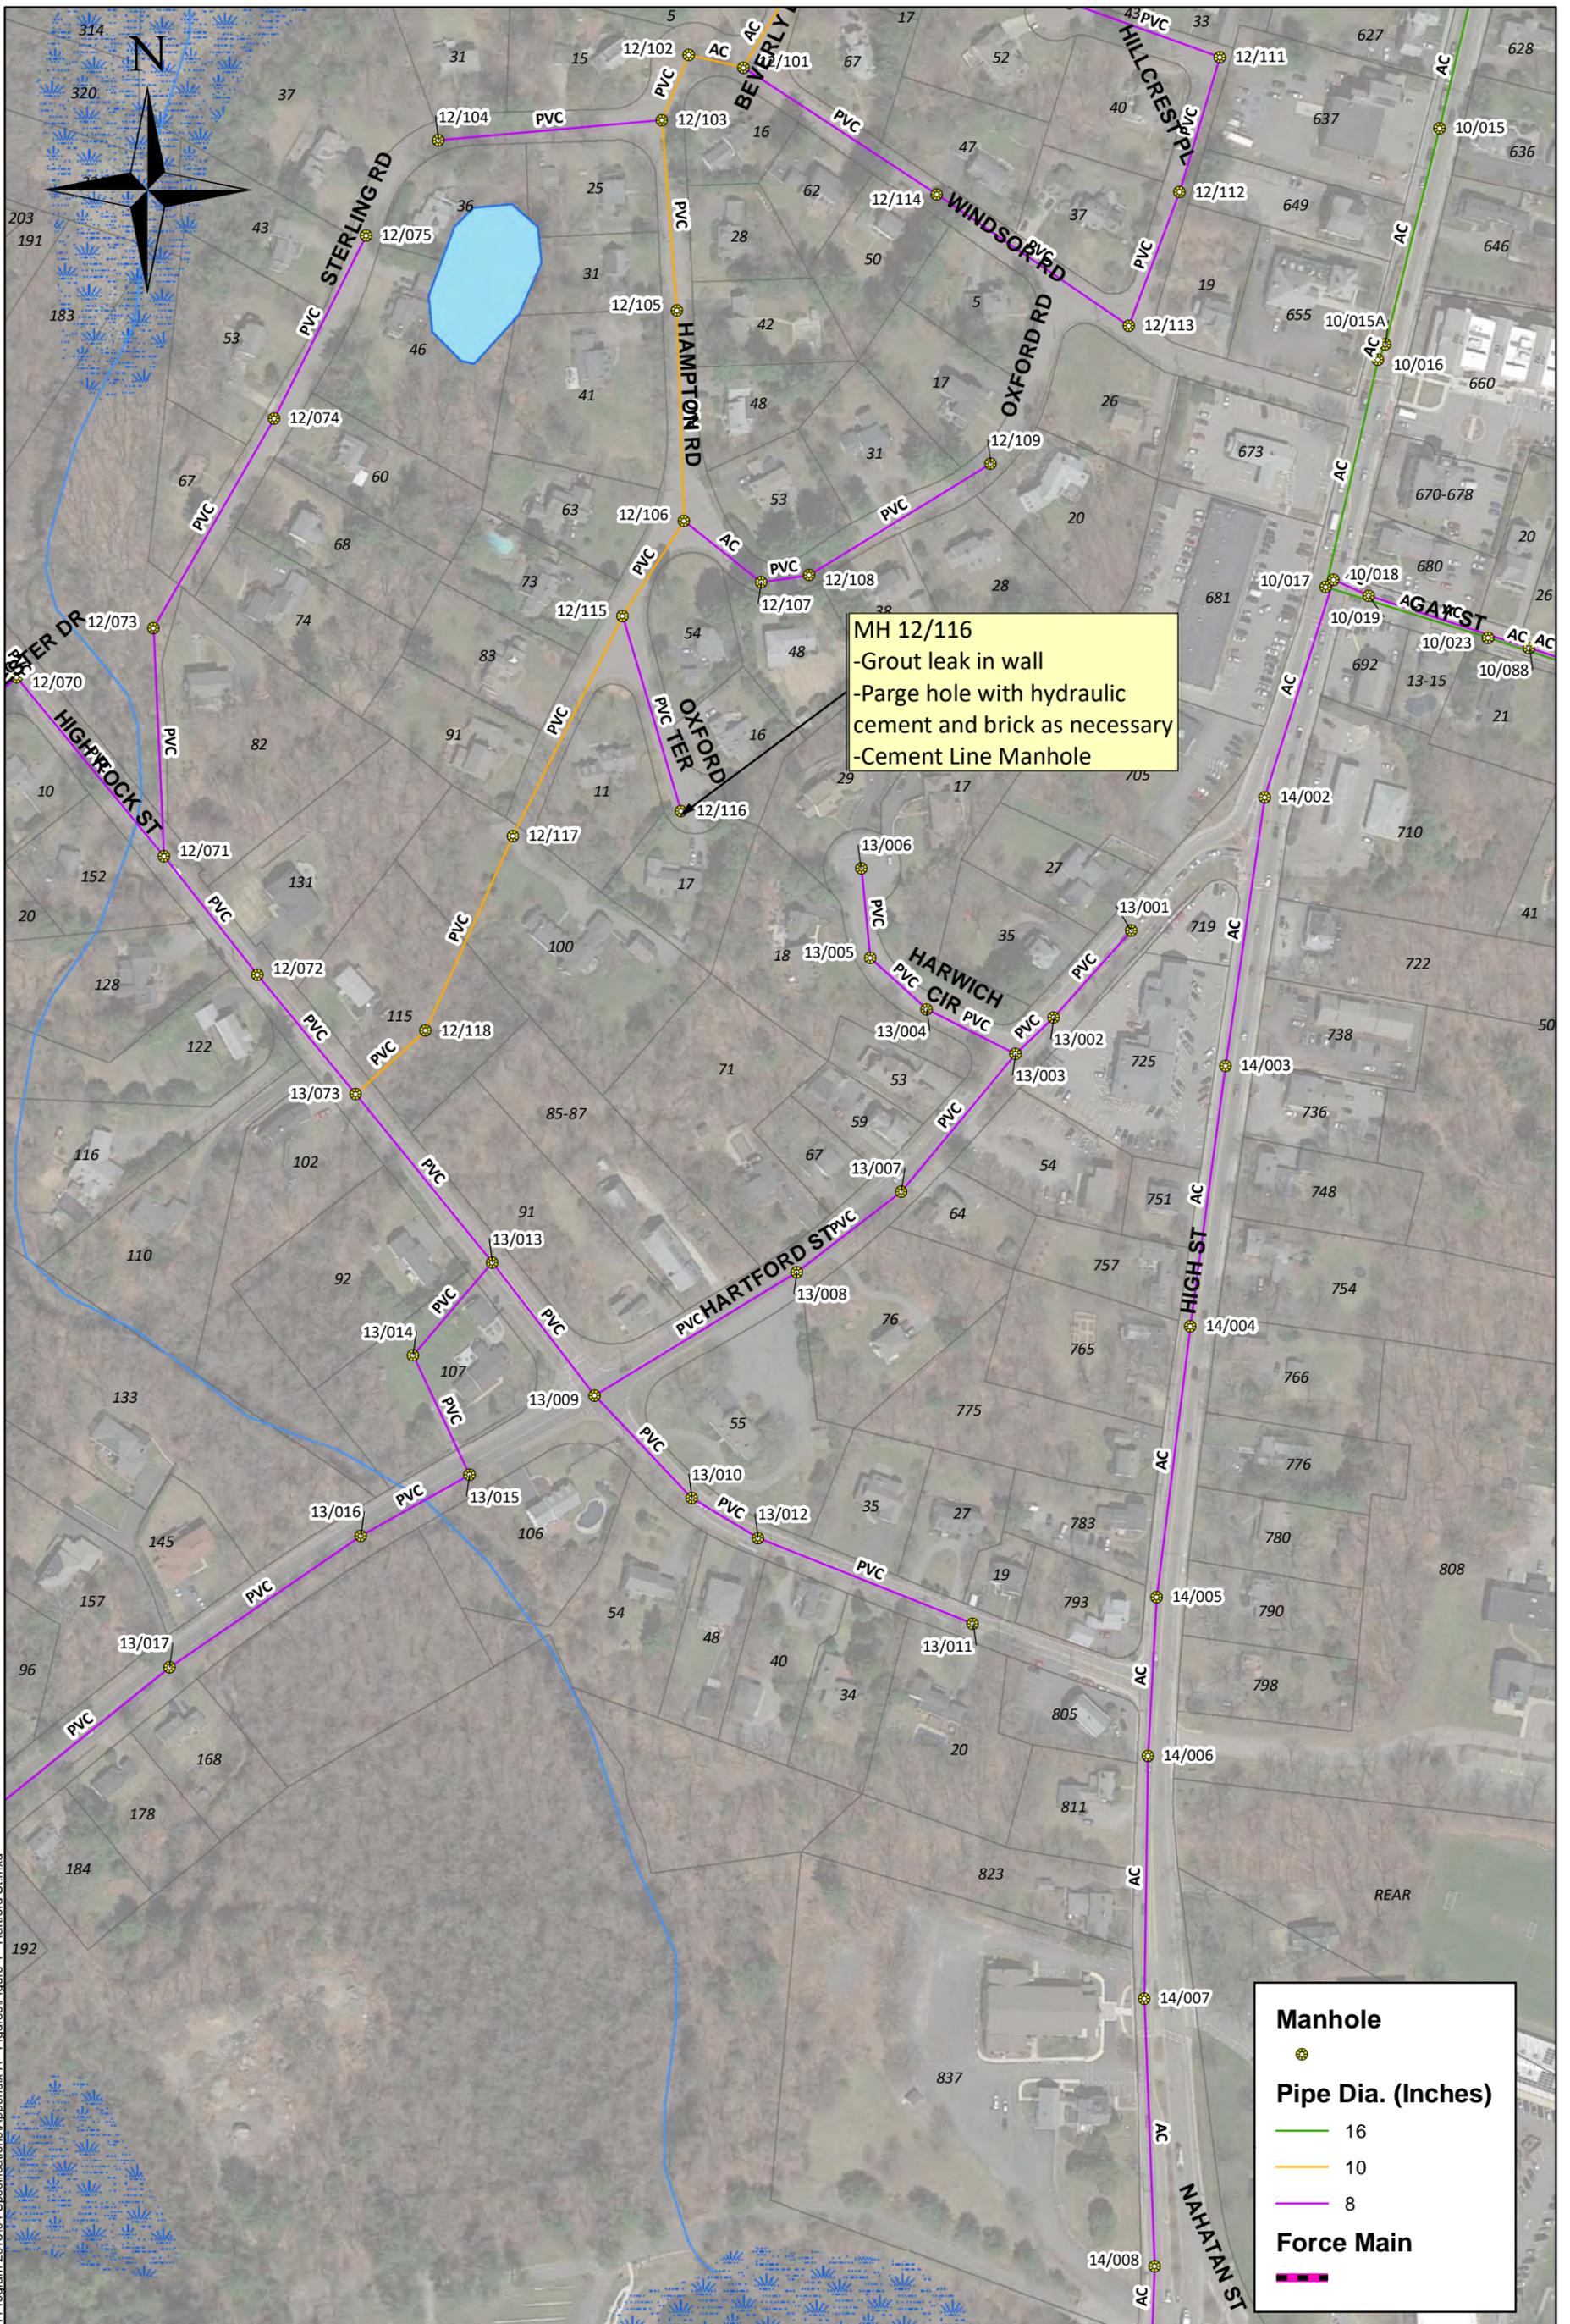
For Bid  
**FIGURE  
3**

MH 12/116  
 -Grout leak in wall  
 -Parge hole with hydraulic cement and brick as necessary  
 -Cement Line Manhole

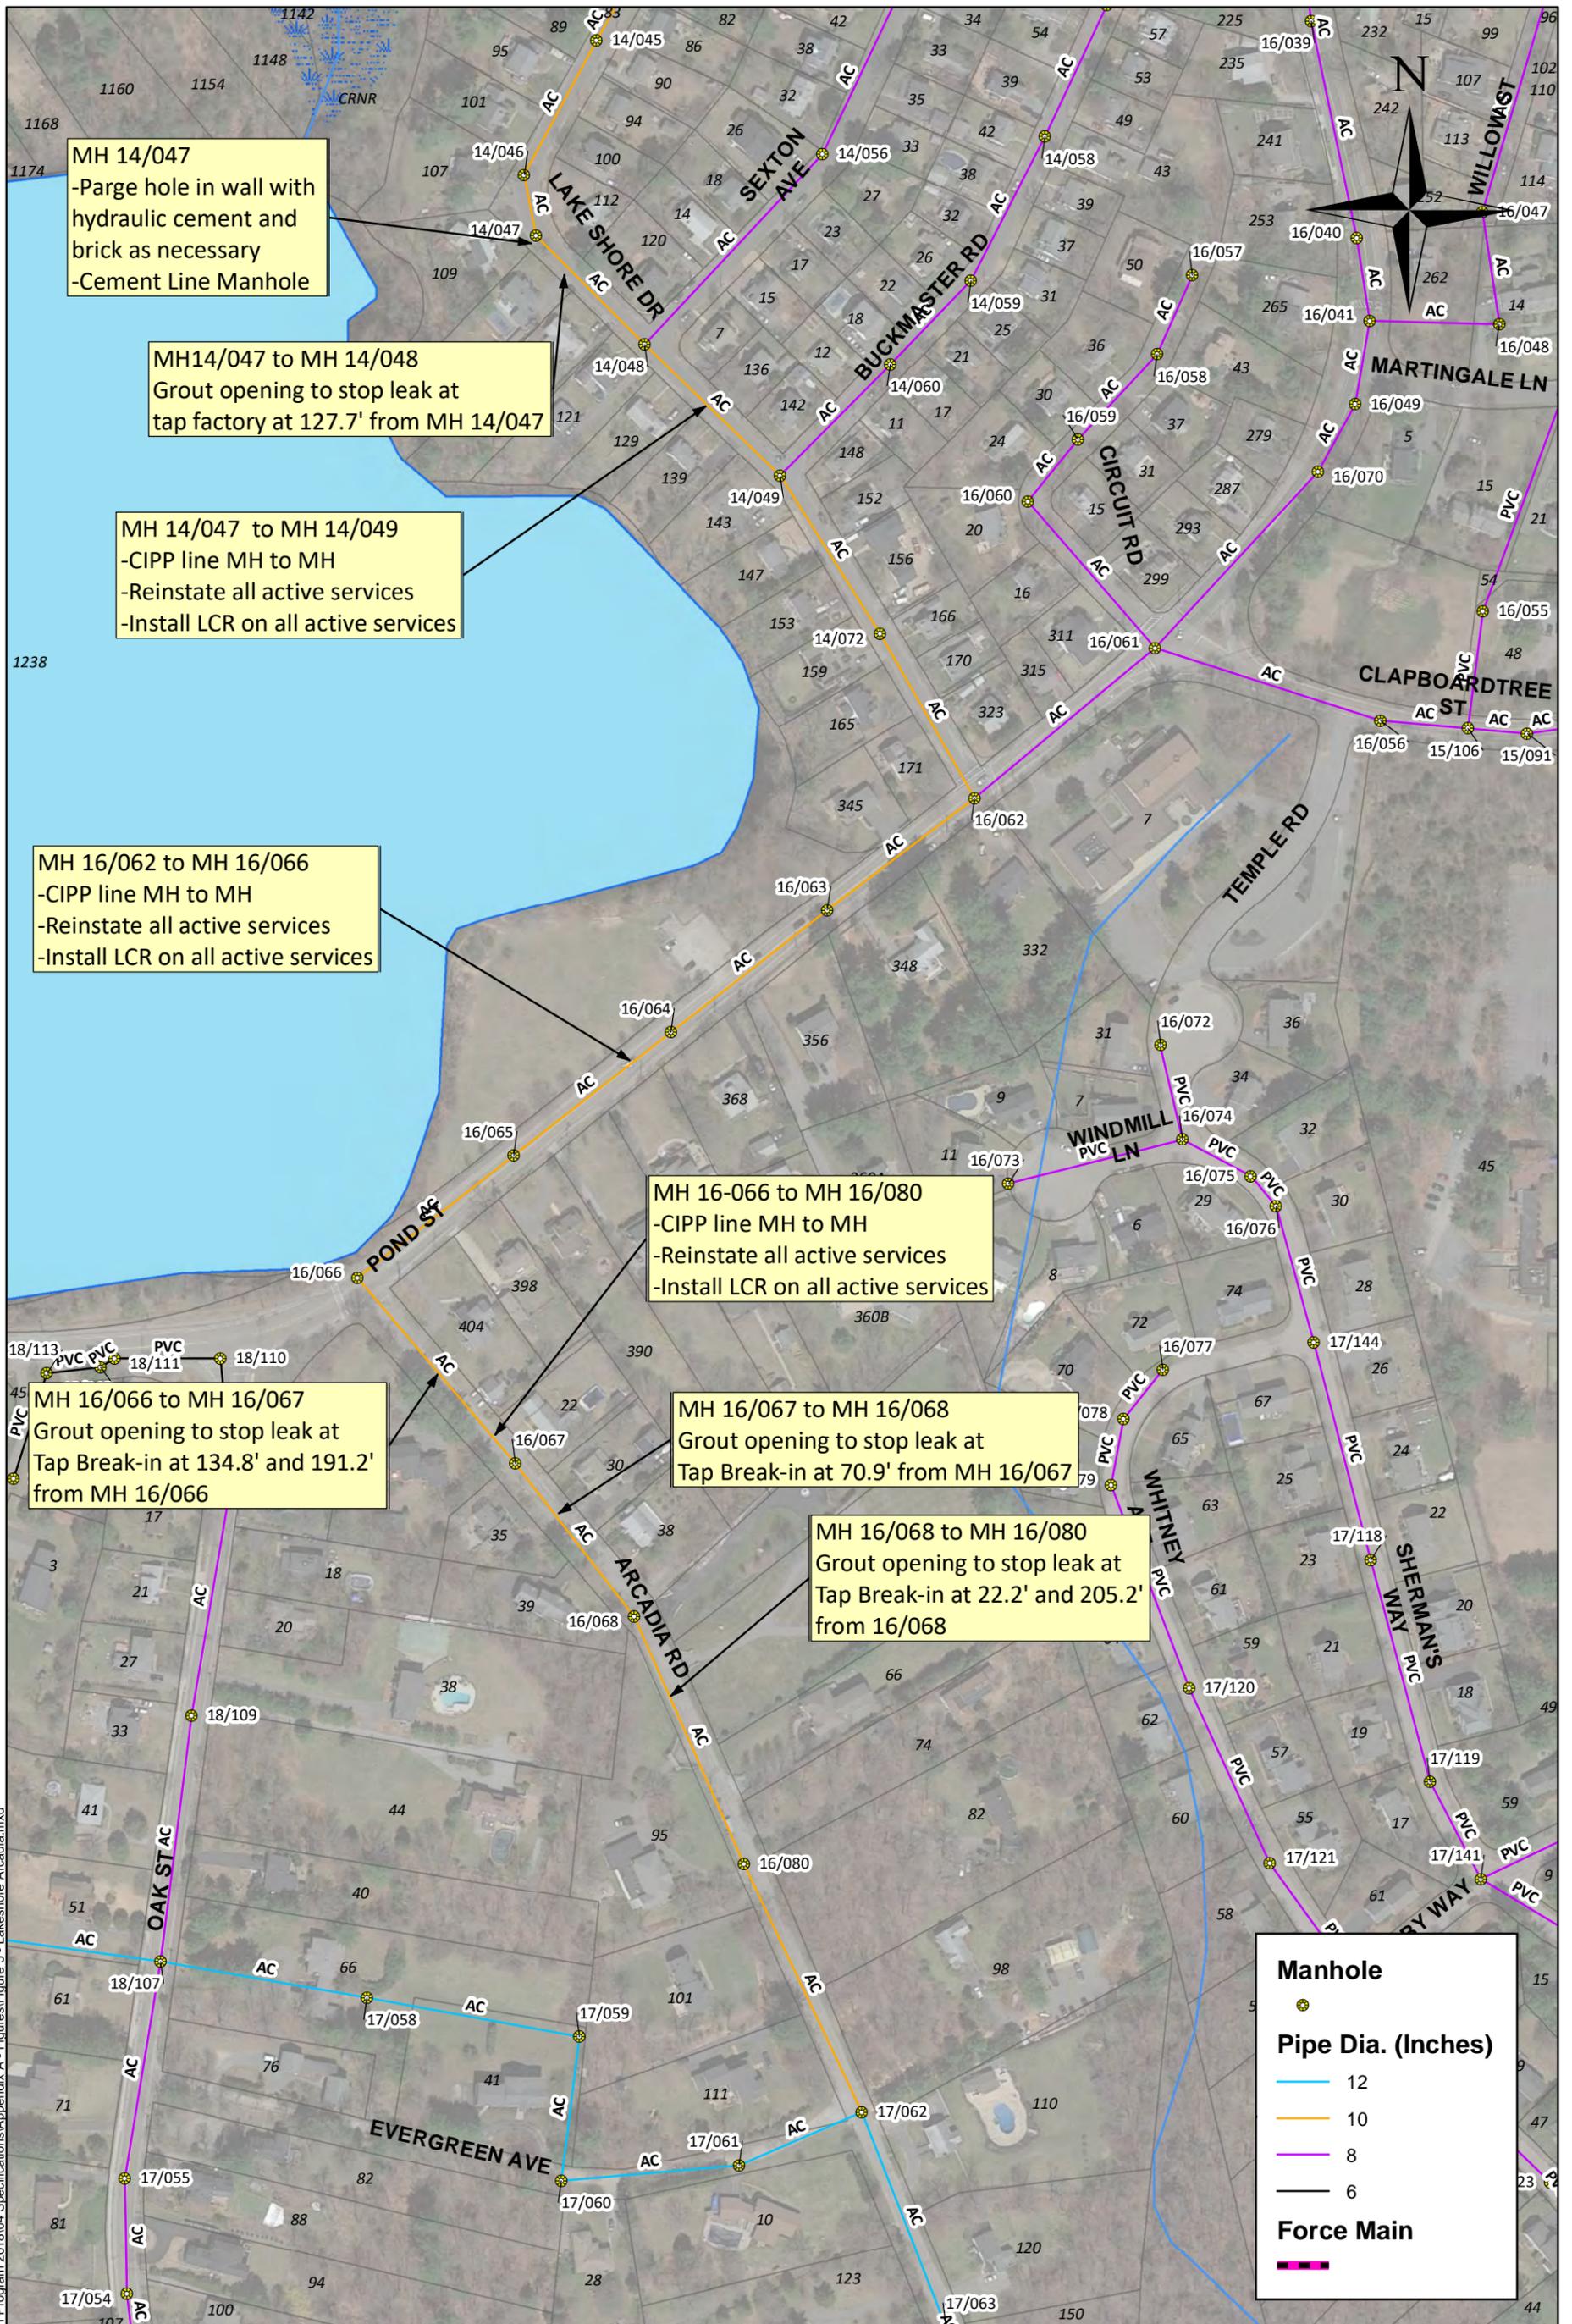
For Bid  
**FIGURE  
 4**

MH 14/047  
 -Parge hole in wall with hydraulic cement and brick as necessary  
 -Cement Line Manhole

MH14/047 to MH 14/048  
 Grout opening to stop leak at tap factory at 127.7' from MH 14/047
