*WESTWOOD SEWER SYSTEM REHABILITATION FIGURES*

**FY19 SEWER SYSTEM REHABILITATION  
 WESTWOOD, MA  
 LOCUS MAP**

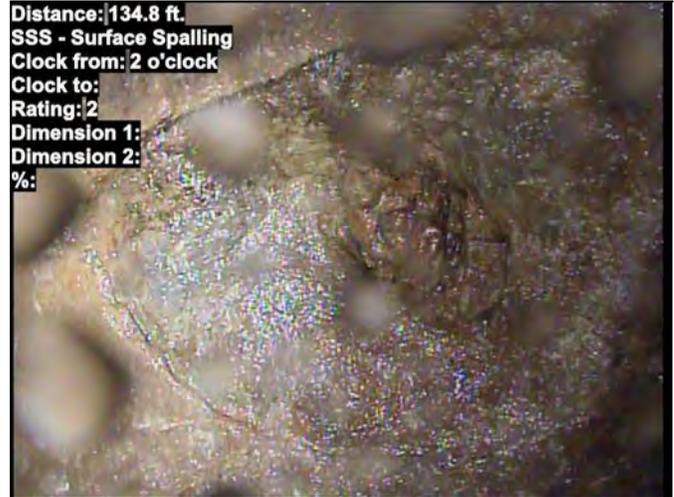
Photo: 16\_066-16\_067-20181113-093245.JPG  
At: 134.8 ft. 2/. SSS - Surface Spalling  
Joint: No

MH 16/066 to MH 16/067  
 Grout opening to stop leak at Tap Break-in at 134.8' and 191.2' from MH 16/066

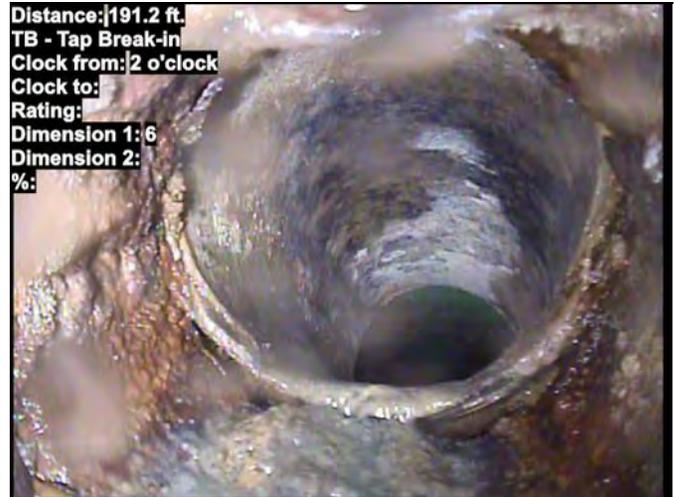
Photo: 16\_066-16\_067-20181113-093522.JPG  
At: 191.2 ft. 2/. TB - Tap Break-in  
Joint: No

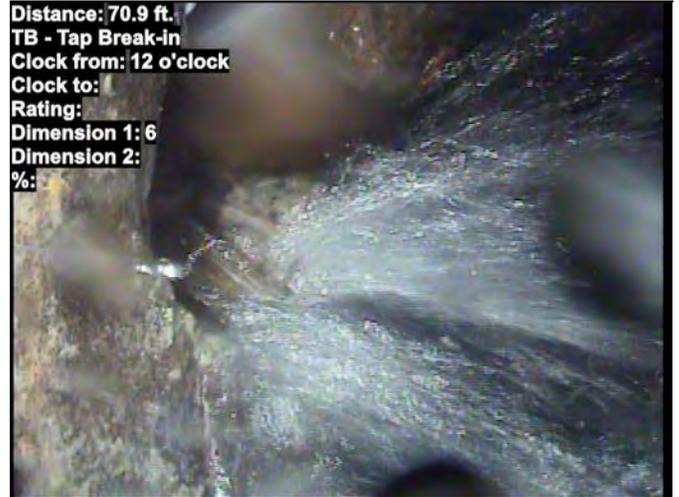
Distance: 70.9 ft.  
TB - Tap Break-in  
Clock from: 12 o'clock  
Clock to:  
Rating:  
Dimension 1: 6  
Dimension 2:  
%:  
Photo: 16\_067-16\_068-20181113-094735.JPG  
At: 70.9 ft. 12/. TB - Tap Break-in  
Joint: No

MH 16/067 to MH 16/068  
 Grout opening to stop leak at Tap Break-in at 70.9' from MH 16/067

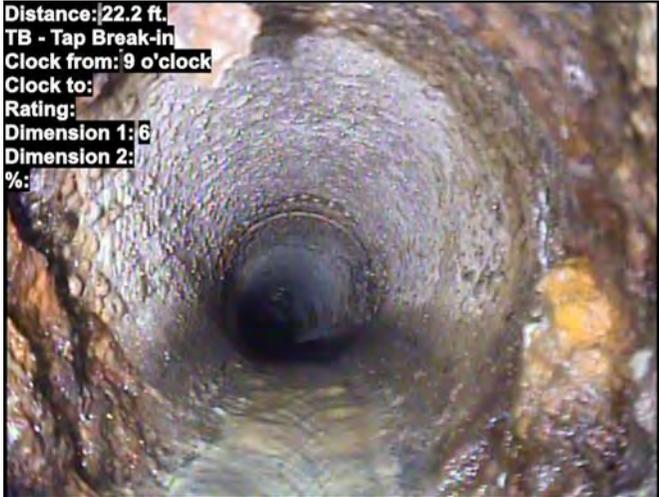
Distance: 22.2 ft.  
TB - Tap Break-in  
Clock from: 9 o'clock  
Clock to:  
Rating:  
Dimension 1: 6  
Dimension 2:  
%:  
Photo: 16\_068-16\_080-20181113-102004.JPG  
At: 22.2 ft. 9/. TB - Tap Break-in  
Joint: No

MH 16/068 to MH 16/080  
 Grout opening to stop leak at Tap Break-in at 22.2' and 205.2' from 16/068

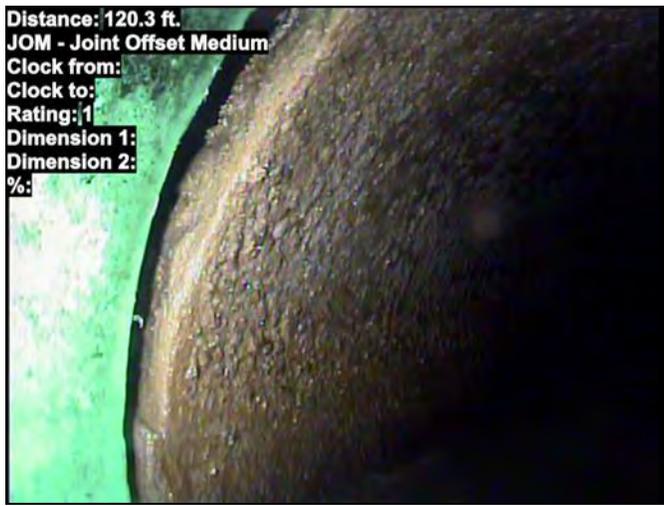
Photo: 16\_068-16\_080-20181113-102418.JPG  
At: 120.3 ft. JOM - Joint Offset Medium  
Joint: No

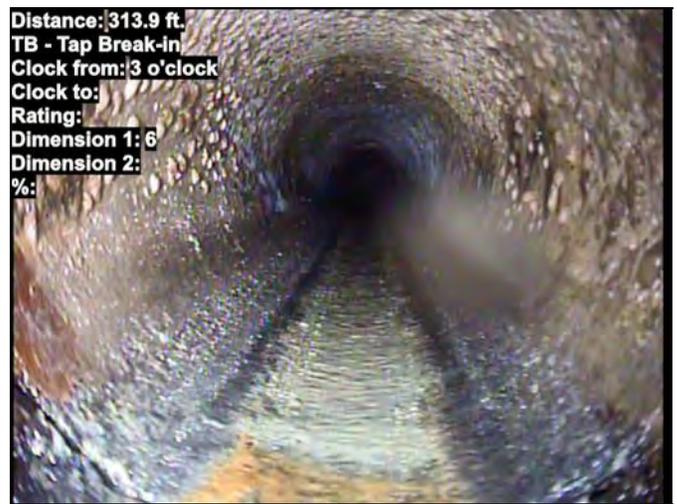
Photo: 16\_068-16\_080-20181113-103057.JPG  
At: 313.9 ft. 3/. TB - Tap Break-in  
Joint: No

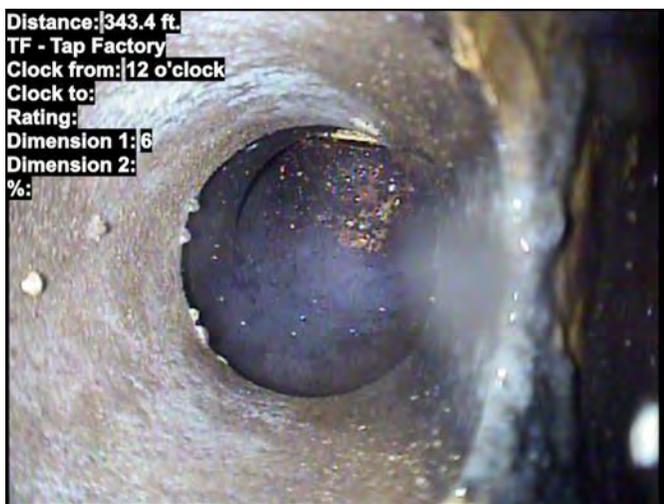
Photo: 16\_068-16\_080-20181113-103214.JPG  
At: 343.4 ft. 12/. TF - Tap Factory  
Joint: No

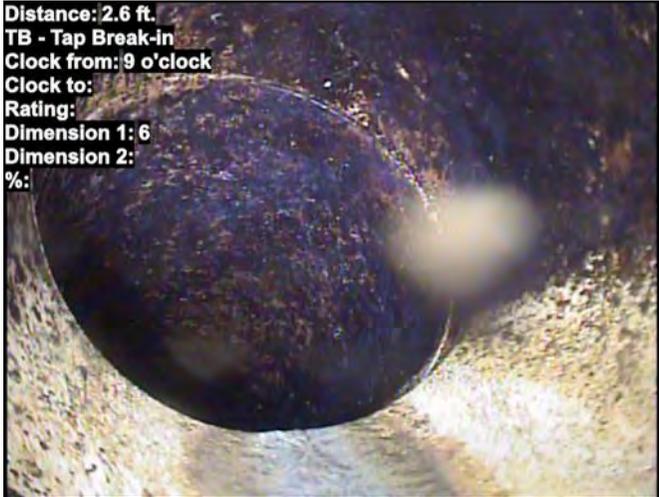
Photo: 16\_080-17\_062-20181113-103526.JPG  
At: 2.6 ft. 9/. TB - Tap Break-in  
Joint: No

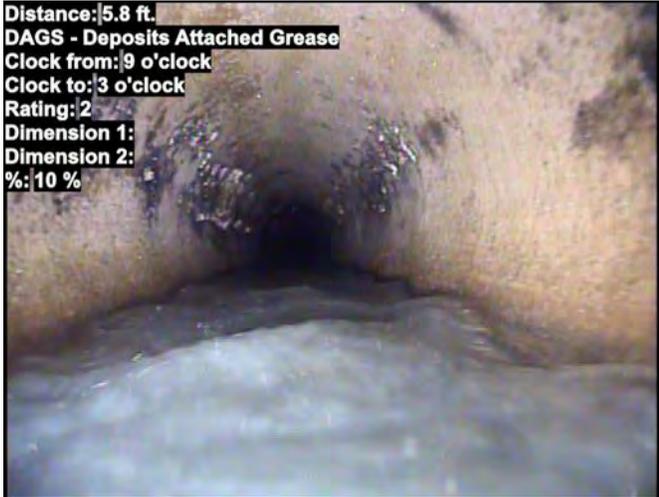
Photo: 14\_072-16\_062-20181113-123915.JPG  
At: 5.8 ft. 9/3 DAGS - Deposits Attached Grease  
Joint: Yes 10 %

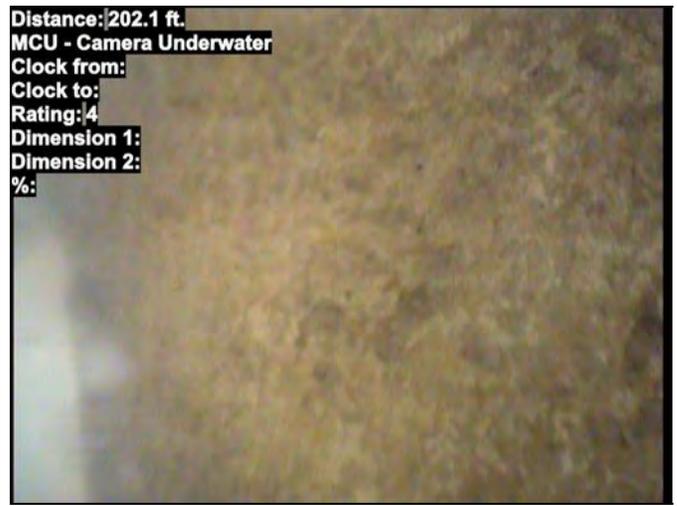
Distance: 202.1 ft.  
MCU - Camera Underwater  
Clock from:  
Clock to:  
Rating: 4  
Dimension 1:  
Dimension 2:  
%:

Photo: 14\_072-16\_062-20181113-125319.JPG  
At: 202.1 ft. MCU - Camera Underwater  
Joint: No

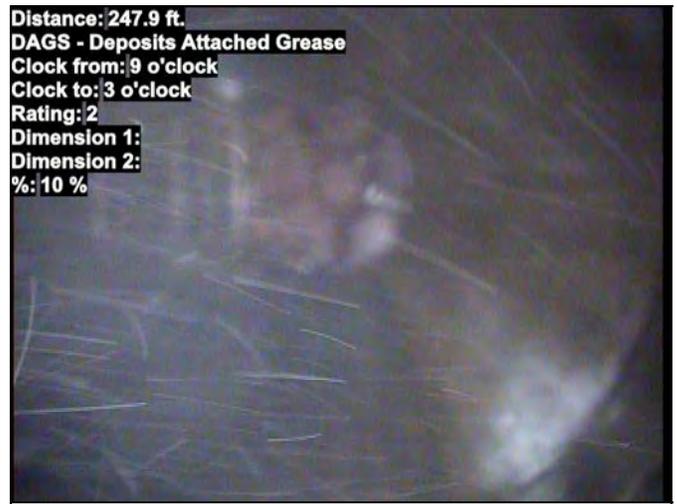
Distance: 247.9 ft.  
DAGS - Deposits Attached Grease  
Clock from: 9 o'clock  
Clock to: 3 o'clock  
Rating: 2  
Dimension 1:  
Dimension 2:  
%: 10 %

Photo: 14\_072-16\_062-20181113-125535.JPG  
At: 247.9 ft. 9/3 DAGS - Deposits Attached Grease  
Joint: Yes 10 %

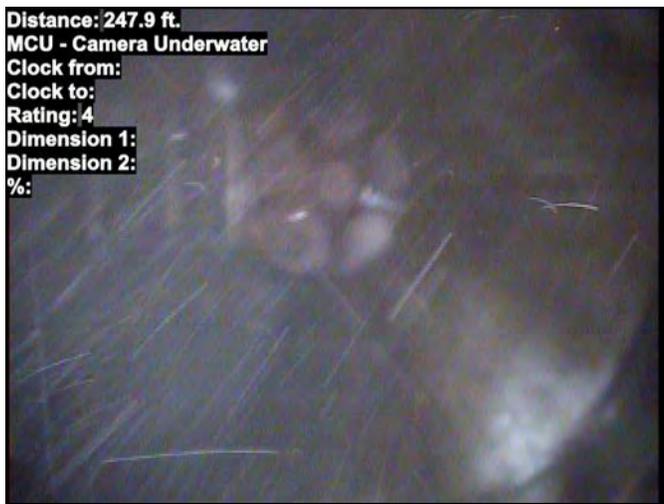
Distance: 247.9 ft.  
MCU - Camera Underwater  
Clock from:  
Clock to:  
Rating: 4  
Dimension 1:  
Dimension 2:  
%:

Photo: 14\_072-16\_062-20181113-125539.JPG  
At: 247.9 ft. MCU - Camera Underwater  
Joint: No

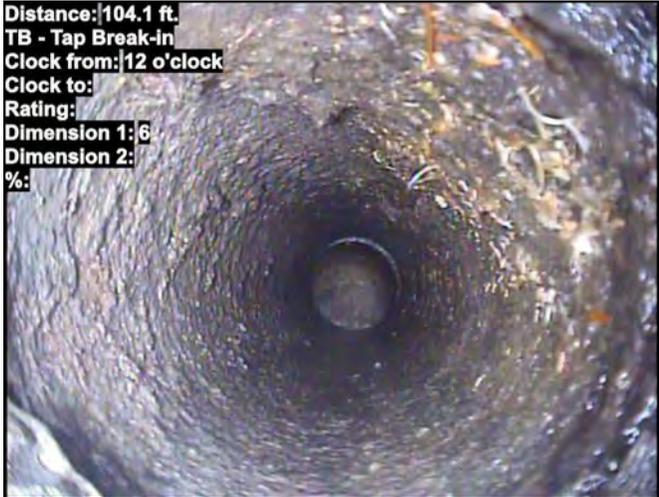
Photo: 16\_062-16\_063-20181114-075733.JPG  
At: 104.1 ft. 12/. TB - Tap Break-in  
Joint: No

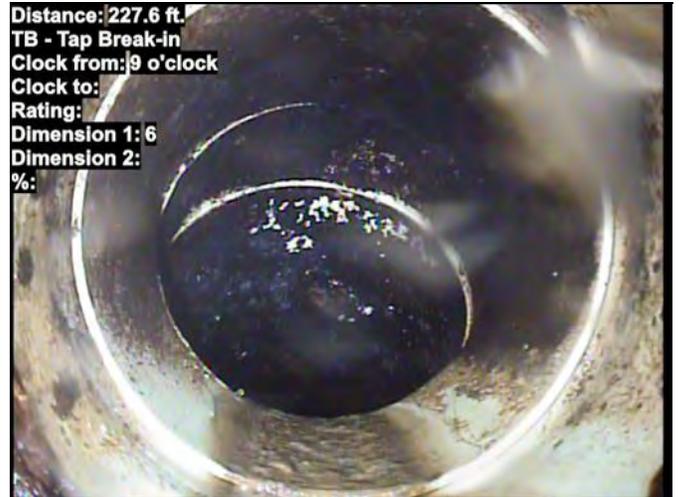
Photo: 16\_064-16\_065-20181114-083649.JPG  
At: 227.6 ft. 9/. TB - Tap Break-in  
Joint: No

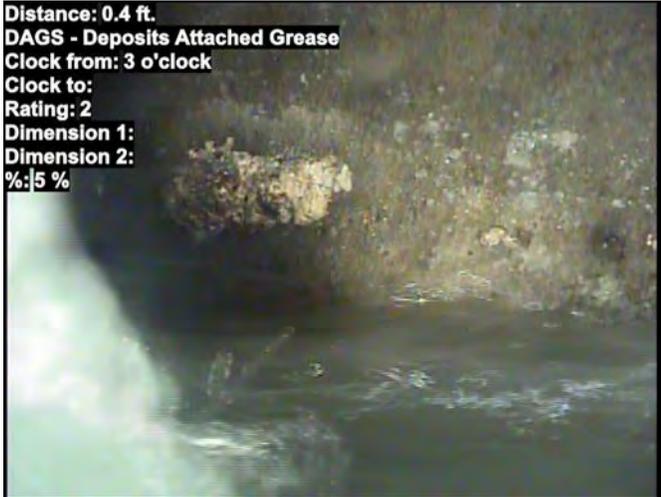
Photo: 16\_065-16\_066-20181114-084618.JPG  
At: 0.4 ft. 3/. DAGS - Deposits Attached Grease  
Joint: No 5 %

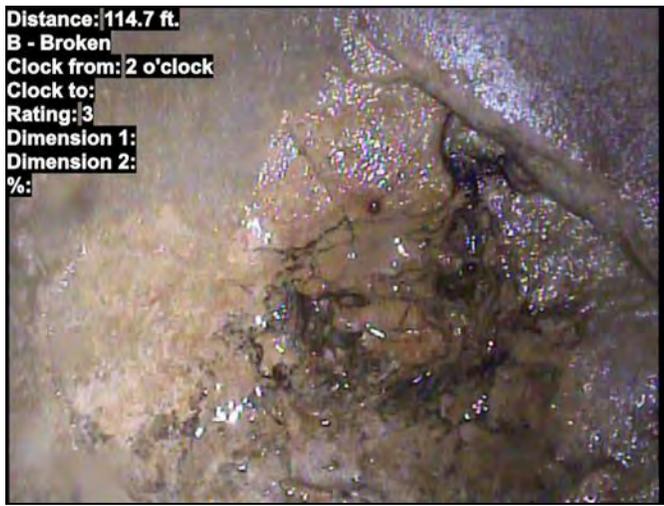
Distance: 114.7 ft.  
B - Broken  
Clock from: 2 o'clock  
Clock to:  
Rating: 3  
Dimension 1:  
Dimension 2:  
%:

Photo: 16\_065-16\_066-20181114-085026.JPG  
At: 114.7 ft. 2/. B - Broken  
Joint: No

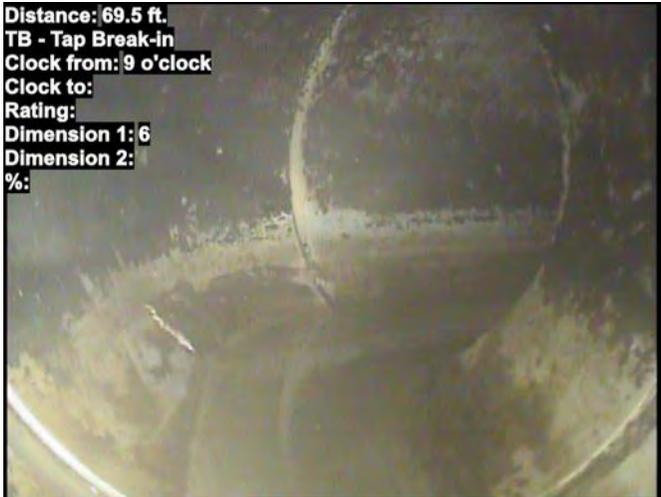
Photo: 13\_002-13\_003-20181114-101117.JPG  
At: 69.5 ft. 9/. TB - Tap Break-in  
Joint: No

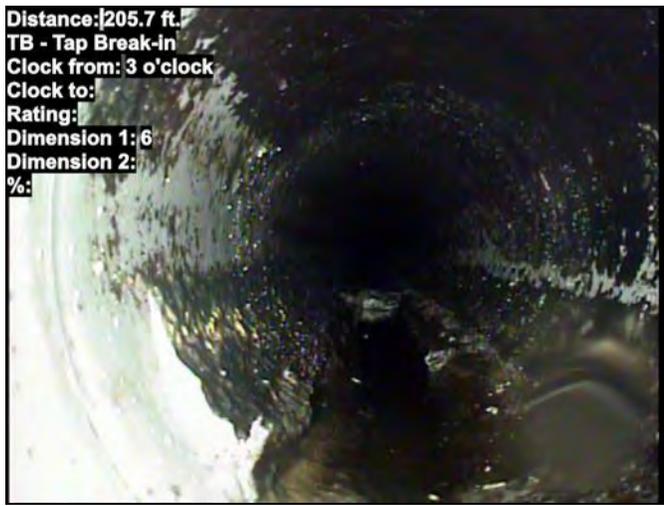
Distance: 205.7 ft.  
TB - Tap Break-in  
Clock from: 3 o'clock  
Clock to:  
Rating:  
Dimension 1: 6  
Dimension 2:  
%:  
Photo: 13\_003-13\_007-20181114-103525.JPG  
At: 205.7 ft. 3/. TB - Tap Break-in  
Joint: No

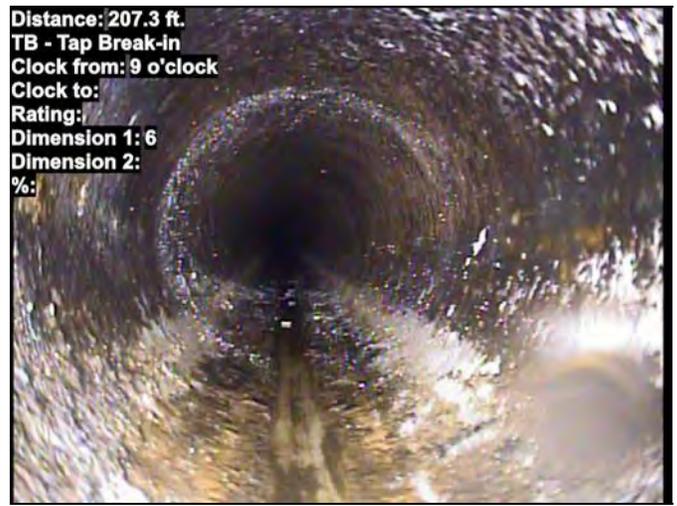
Distance: 207.3 ft.  
TB - Tap Break-in  
Clock from: 9 o'clock  
Clock to:  
Rating:  
Dimension 1: 6  
Dimension 2:  
%:  
Photo: 13\_003-13\_007-20181114-103541.JPG  
At: 207.3 ft. 9/. TB - Tap Break-in  
Joint: No

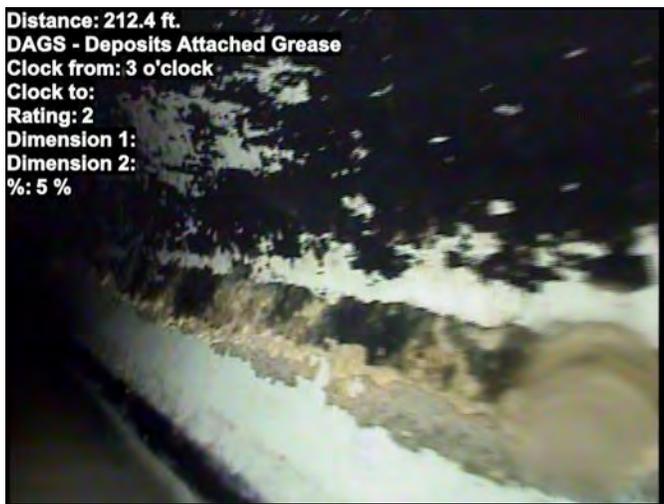
Distance: 212.4 ft.  
DAGS - Deposits Attached Grease  
Clock from: 3 o'clock  
Clock to:  
Rating: 2  
Dimension 1:  
Dimension 2:  
%: 5 %  
Photo: 13\_003-13\_007-20181114-103602.JPG  
At: 212.4 ft. 3/. DAGS - Deposits Attached Grease  
Joint: No 5 %

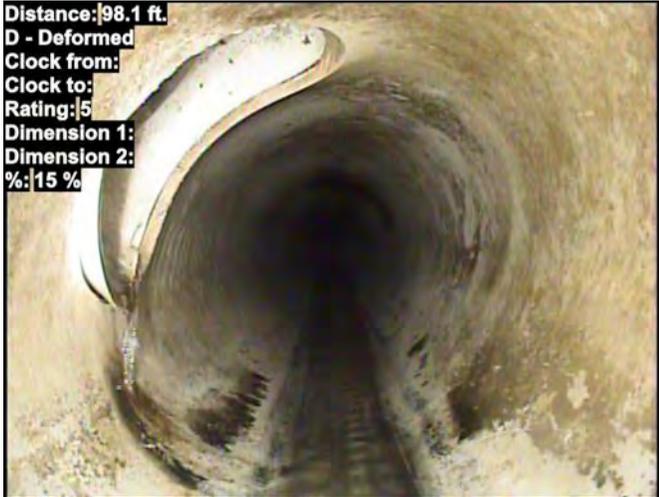
Distance: 98.1 ft.  
D - Deformed  
Clock from:  
Clock to:  
Rating: 5  
Dimension 1:  
Dimension 2:  
%: 15 %  
Photo: 13\_008-13\_009-20181114-110526.JPG  
At: 98.1 ft. D - Deformed  
Joint: No 15 %

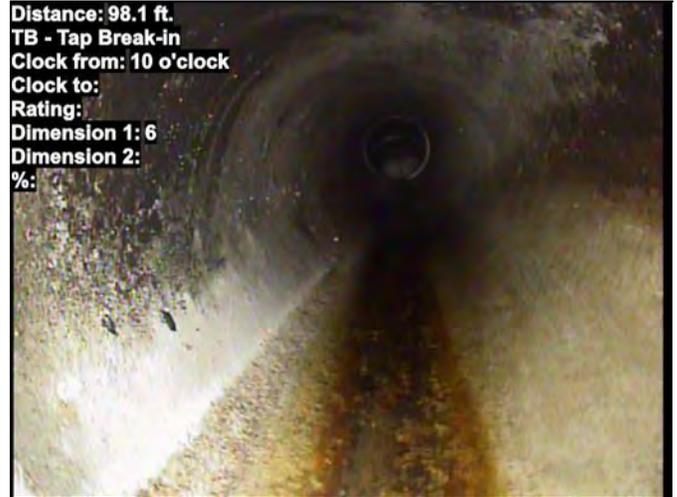
Distance: 98.1 ft.  
TB - Tap Break-in  
Clock from: 10 o'clock  
Clock to:  
Rating:  
Dimension 1: 6  
Dimension 2:  
%:  
Photo: 13\_008-13\_009-20181114-110510.JPG  
At: 98.1 ft. 10/. TB - Tap Break-in  
Joint: No

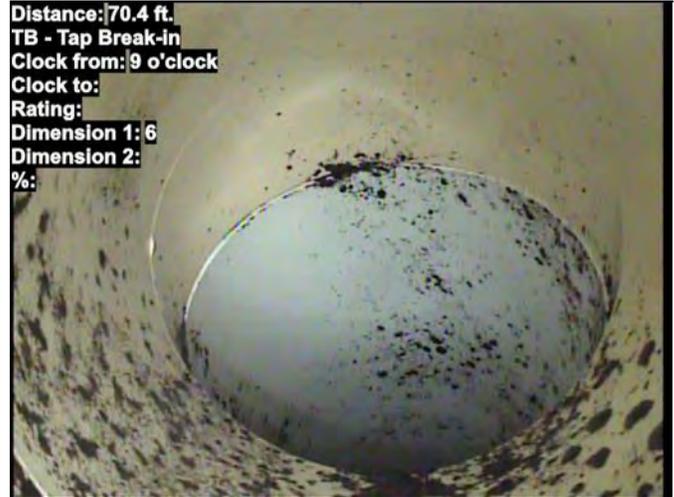
Photo: 13\_007-13\_008-20181114-112541.JPG  
At: 70.4 ft. 9/. TB - Tap Break-in  
Joint: No

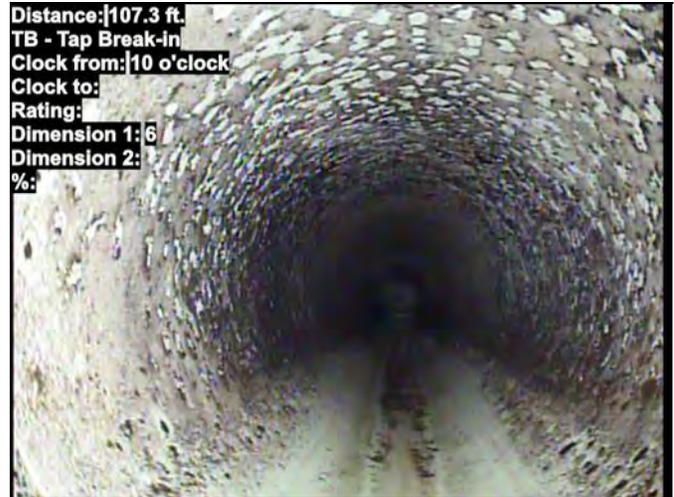
Photo: 13\_007-13\_008-20181114-112709.JPG  
At: 107.3 ft. 10/. TB - Tap Break-in  
Joint: No

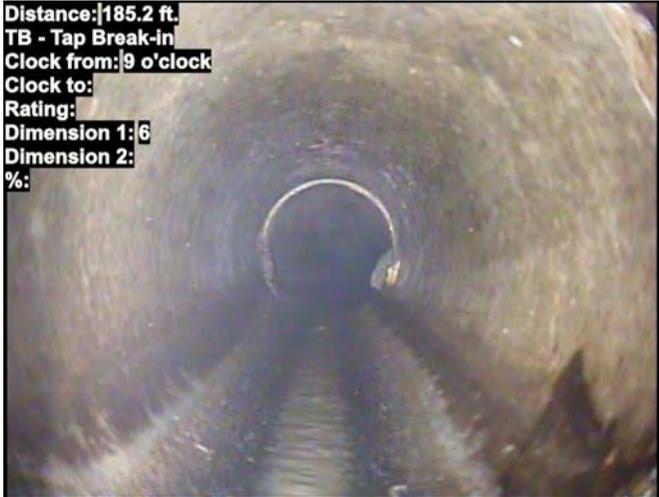
Distance: 185.2 ft.  
TB - Tap Break-in  
Clock from: 9 o'clock  
Clock to:  
Rating:  
Dimension 1: 6  
Dimension 2:  
%:

Photo: 10\_073-10\_072-20181115-094348.JPG  
At: 185.2 ft. 9/. TB - Tap Break-in  
Joint: No

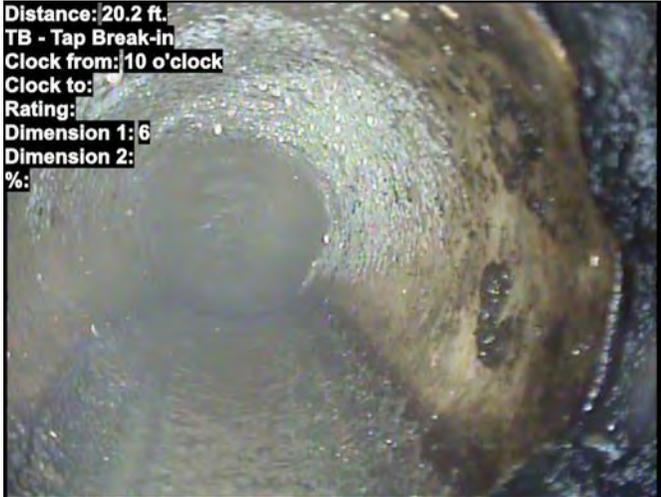
Distance: 20.2 ft.  
TB - Tap Break-in  
Clock from: 10 o'clock  
Clock to:  
Rating:  
Dimension 1: 6  
Dimension 2:  
%:

Photo: 10\_077-10\_078-20181115-103147.JPG  
At: 20.2 ft. 10/. TB - Tap Break-in  
Joint: No

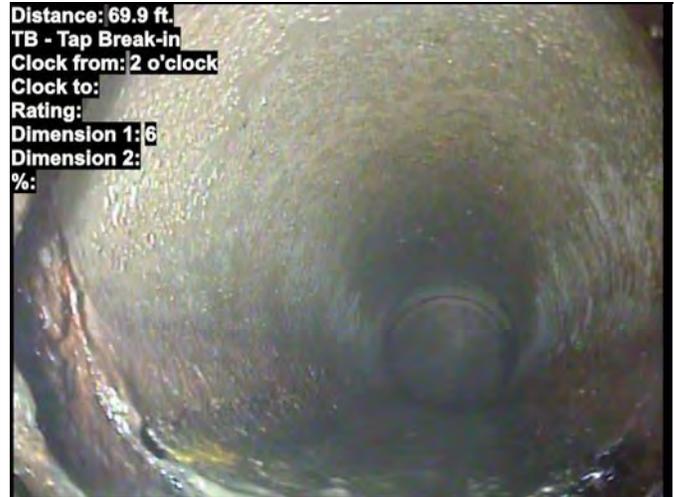
Photo: 10\_078-10\_079-20181115-103933.JPG  
At: 69.9 ft. 2/. TB - Tap Break-in  
Joint: No

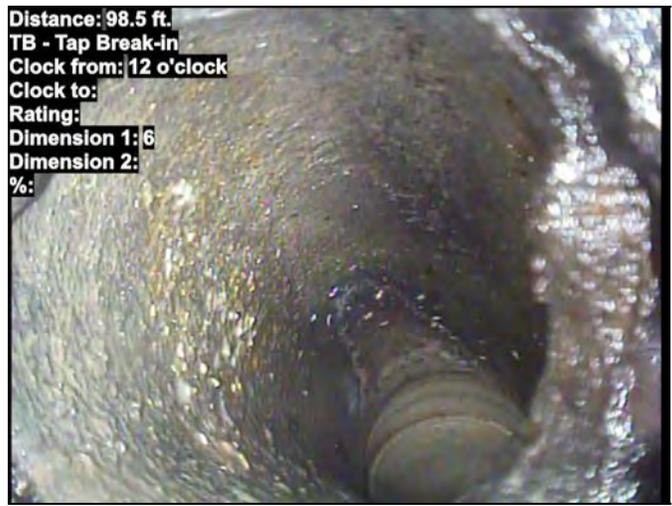
Distance: 98.5 ft.  
TB - Tap Break-in  
Clock from: 12 o'clock  
Clock to:  
Rating:  
Dimension 1: 6  
Dimension 2:  
%:  
Photo: 10\_078-10\_079-20181115-104108.JPG  
At: 98.5 ft. 12/. TB - Tap Break-in  
Joint: No

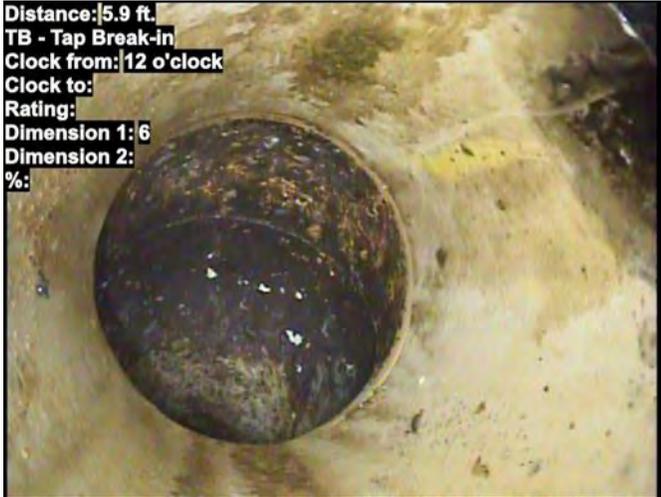
Photo: 10\_022-10\_081-20181115-112951.JPG  
At: 5.9 ft. 12/. TB - Tap Break-in  
Joint: No

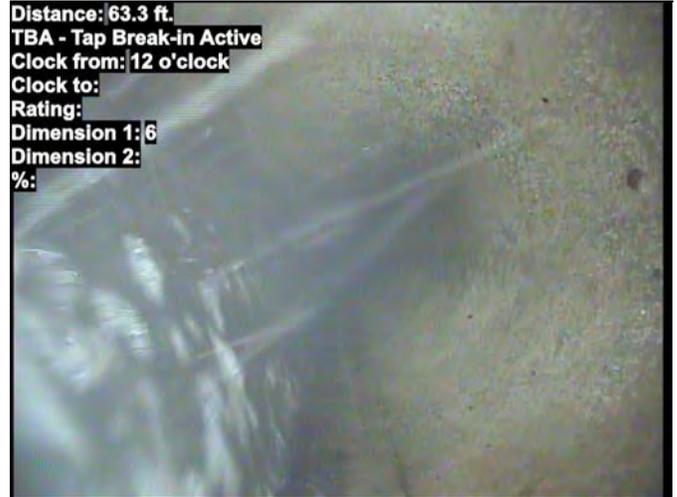
Photo: 10\_022-10\_081-20181115-113145.JPG  
At: 63.3 ft. 12/. TBA - Tap Break-in Active  
Joint: No

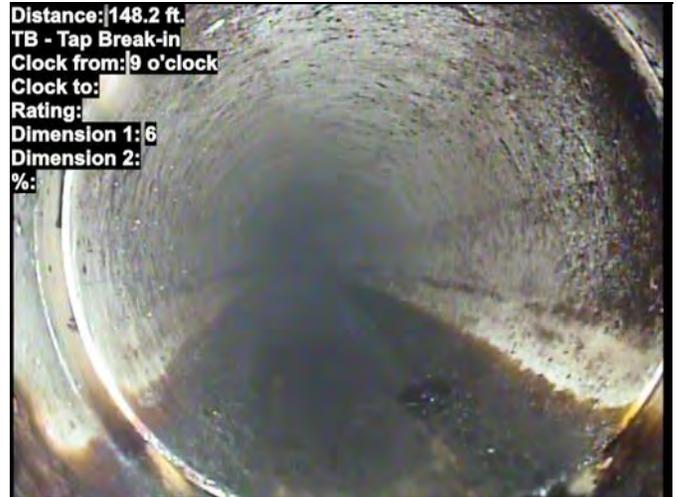
Photo: 10\_022-10\_081-20181115-113457.JPG  
At: 148.2 ft. 9/. TB - Tap Break-in  
Joint: No

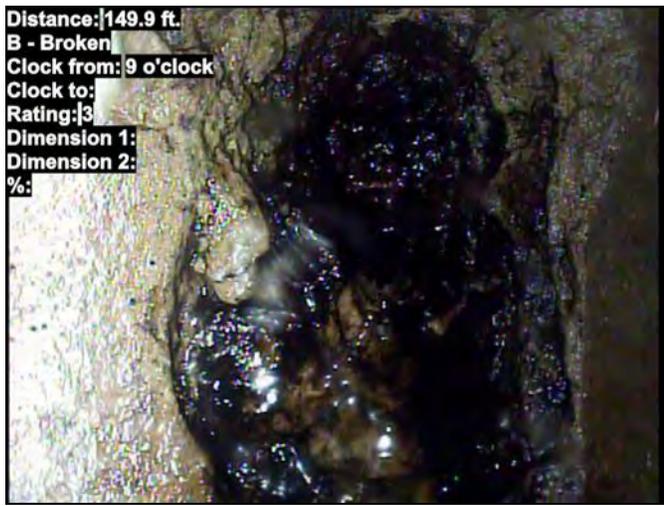
Distance: 149.9 ft.

B - Broken

At: 149.9 ft. 9/. B - Broken

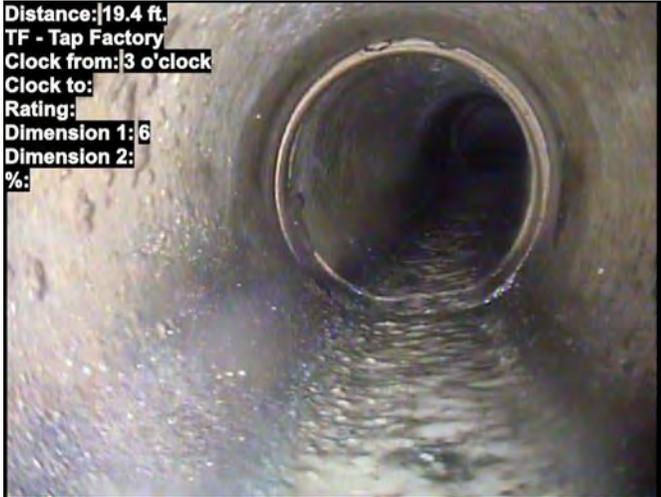
Photo: 10\_020-10\_088-20181115-115159.JPG  
At: 19.4 ft. 3/. TF - Tap Factory  
Joint: No

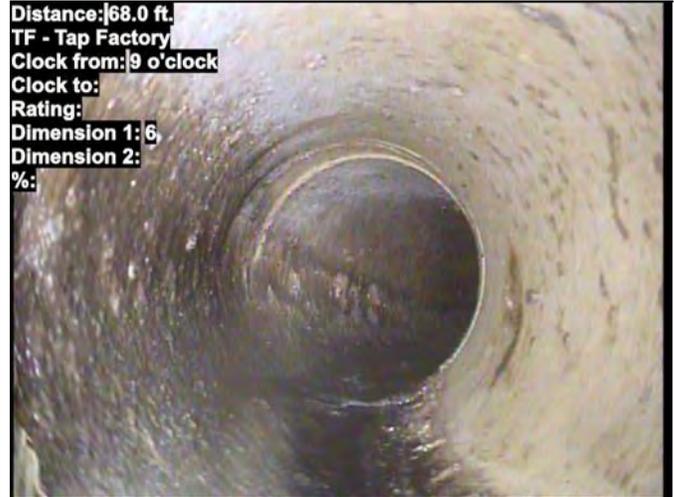
Photo: 10\_020-10\_088-20181115-115413.JPG  
At: 68 ft. 9/. TF - Tap Factory  
Joint: No

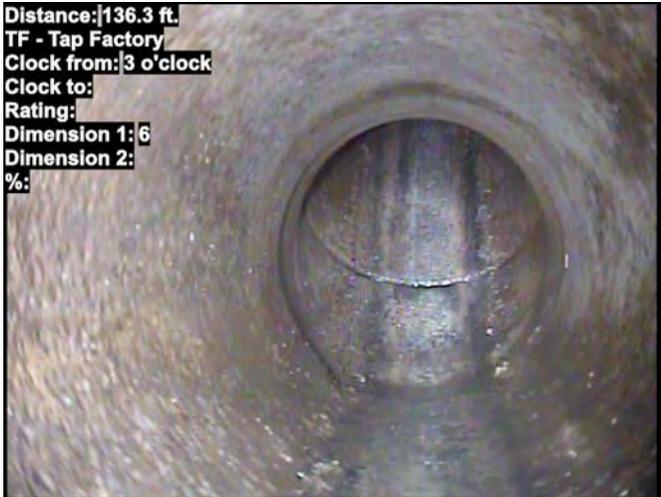
Photo: 10\_020-10\_088-20181115-115625.JPG  
At: 136.3 ft. 3/. TF - Tap Factory  
Joint: No

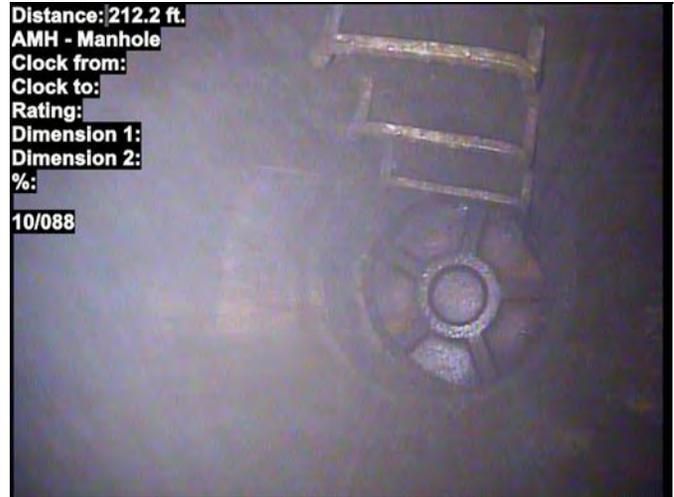
Photo: 10\_020-10\_088-20181115-115919.JPG  
At: 212.2 ft. AMH - Manhole  
Joint: No 10/088

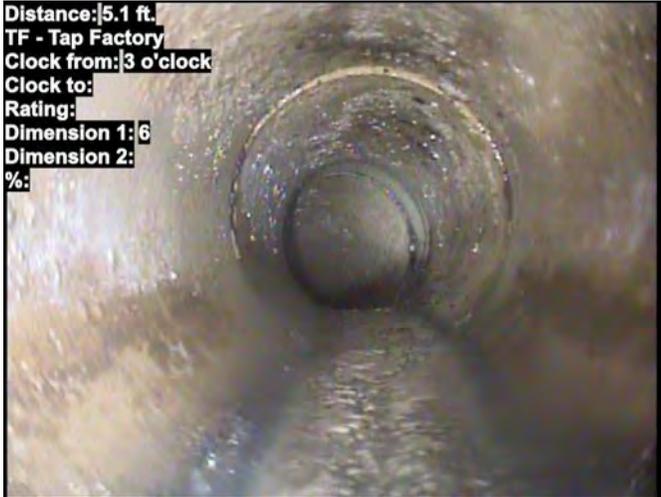
At: 5.1 ft. 3/. TF - Tap Factory

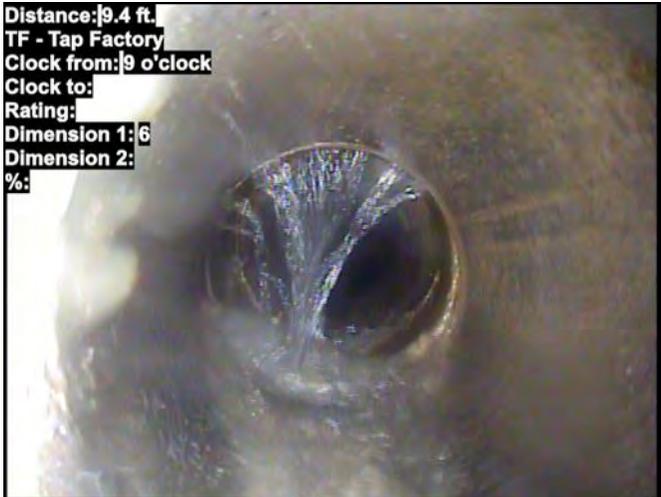
At: 9.4 ft. 9/. TF - Tap Factory

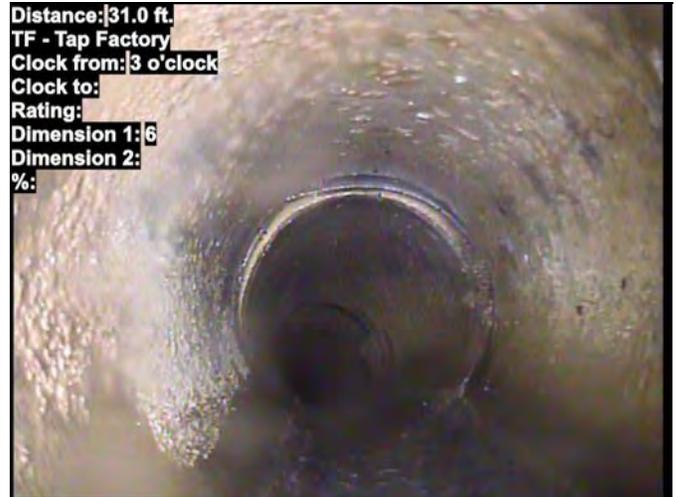
At: 31 ft. 3/. TF - Tap Factory

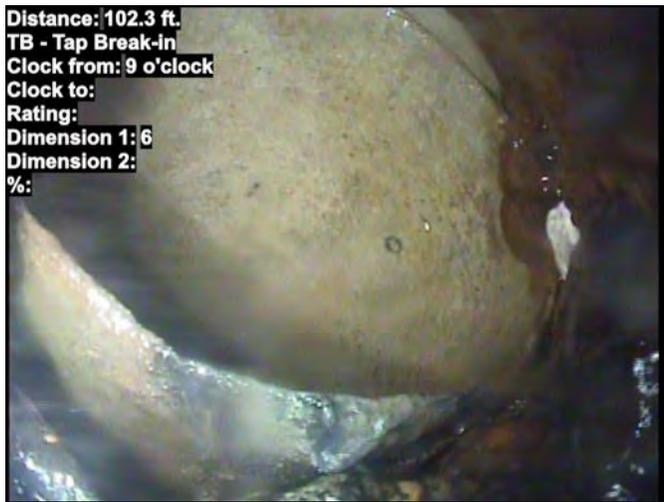
Photo: 10\_088-10\_019-20181115-123234.JPG  
At: 102.3 ft. 9/. TB - Tap Break-in  
Joint: No

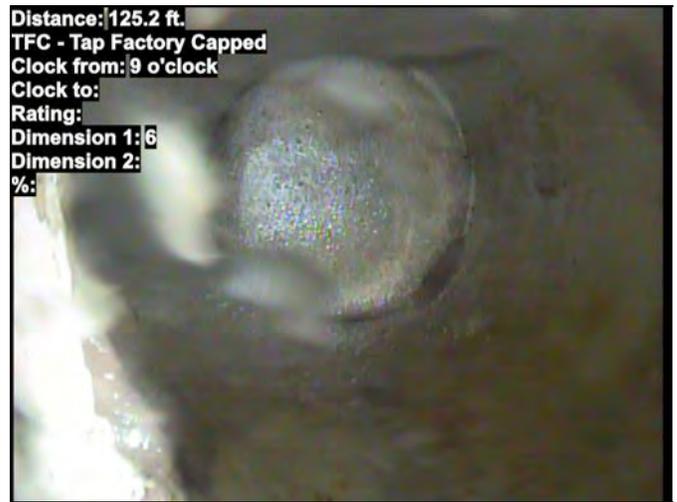
Photo: 10\_088-10\_019-20181115-123324.JPG  
At: 125.2 ft. 9/. TFC - Tap Factory Capped  
Joint: No

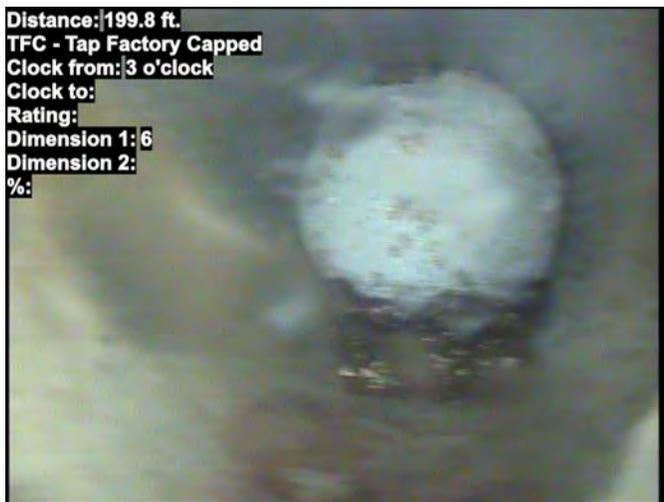
Photo: 10\_088-10\_019-20181115-123531.JPG  
At: 199.8 ft. 3/. TFC - Tap Factory Capped  
Joint: No

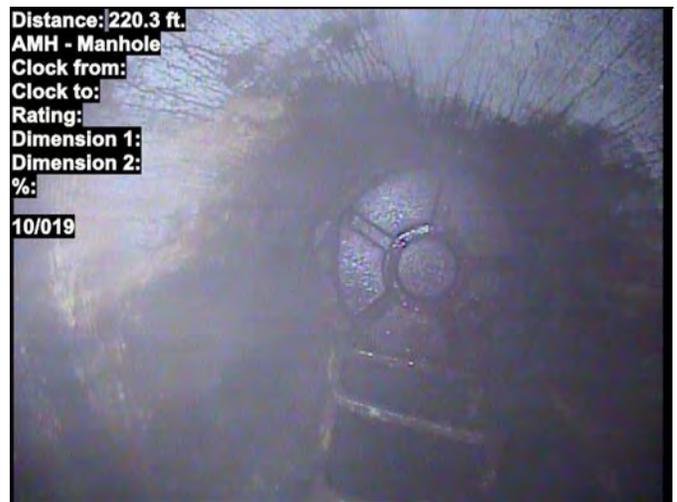
Photo: 10\_088-10\_019-20181115-123636.JPG  
At: 220.3 ft. AMH - Manhole  
Joint: No 10/019

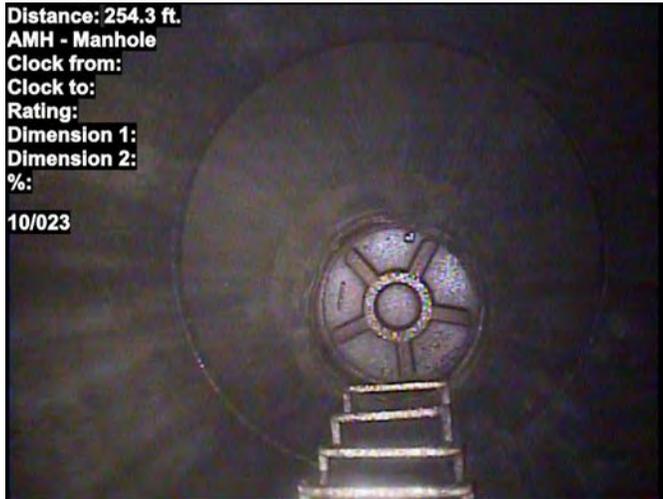
At: 254.3 ft. AMH - Manhole

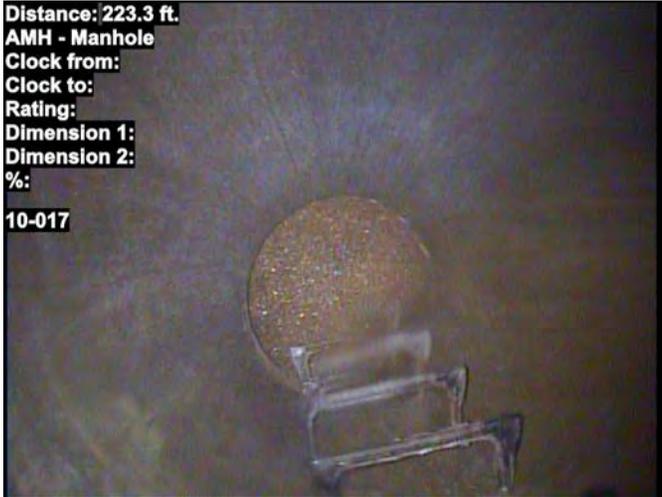
At: 223.3 ft. AMH - Manhole

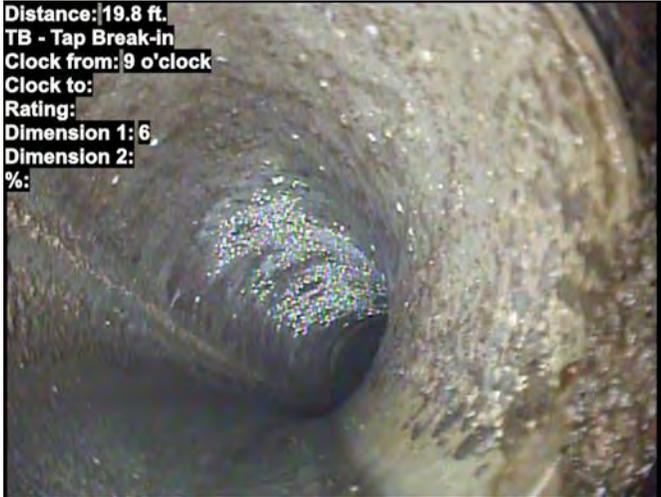
At: 19.8 ft. 9/. TB - Tap Break-in

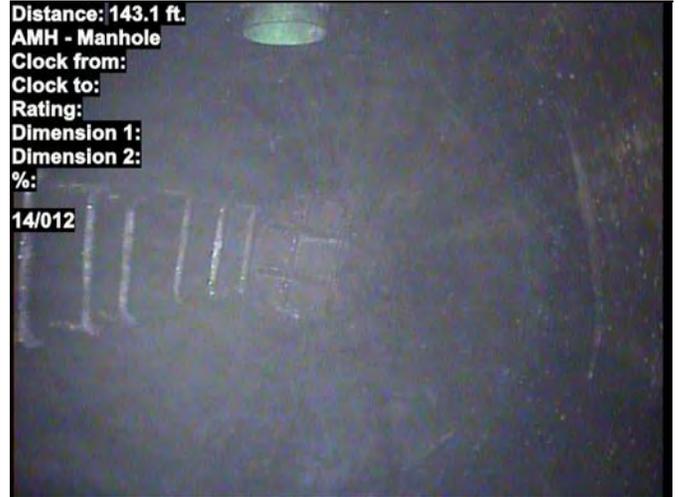
At: 143.1 ft. AMH - Manhole

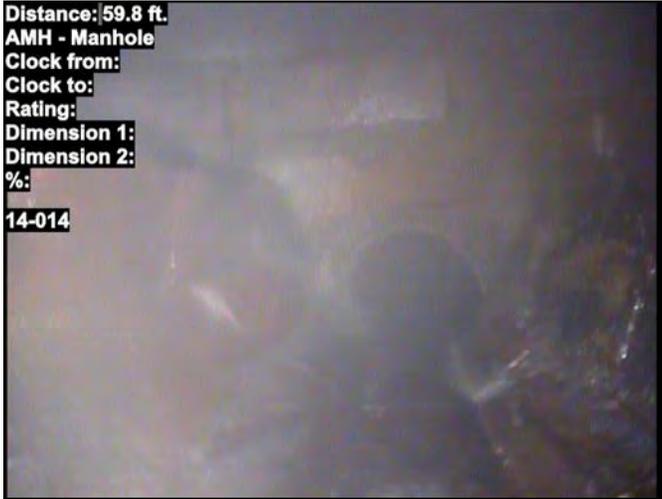
At: 59.8 ft. AMH - Manhole

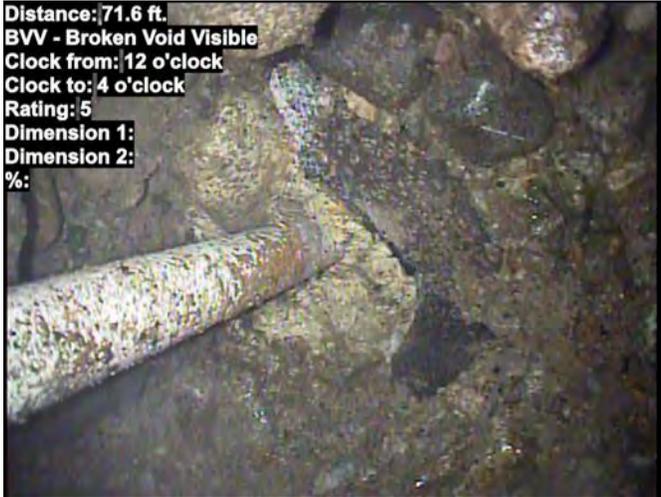
Photo: 14\_071-14\_013-20181116-090045.JPG  
At: 71.6 ft. 12/4 BVV - Broken Void Visible  
Joint: No

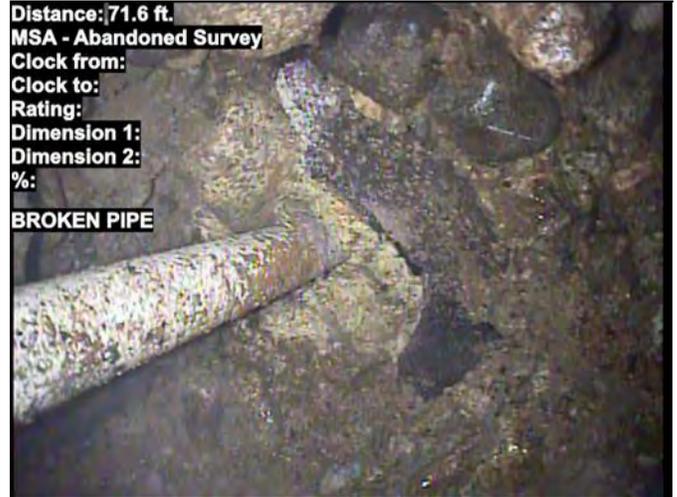
Photo: 14\_071-14\_013-20181116-090119.JPG  
At: 71.6 ft. MSA - Abandoned Survey  
Joint: No **BROKEN PIPE**

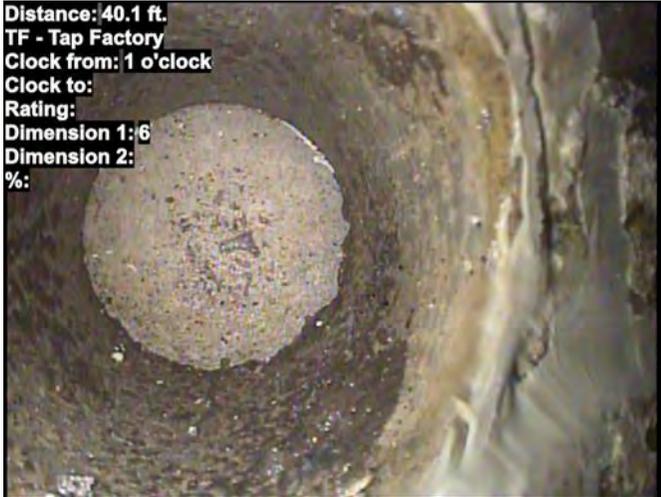
Photo: 14\_013-14\_017-20181116-090913.JPG  
At: 40.1 ft. 1/. TF - Tap Factory  
Joint: No

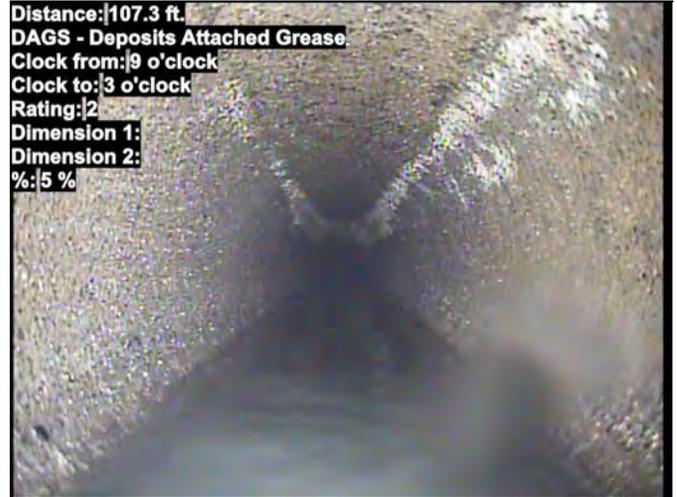
Photo: 14\_013-14\_017-20181116-091123.JPG  
At: 107.3 ft. 9/3 DAGS - Deposits Attached Grease  
Joint: Yes 5 %

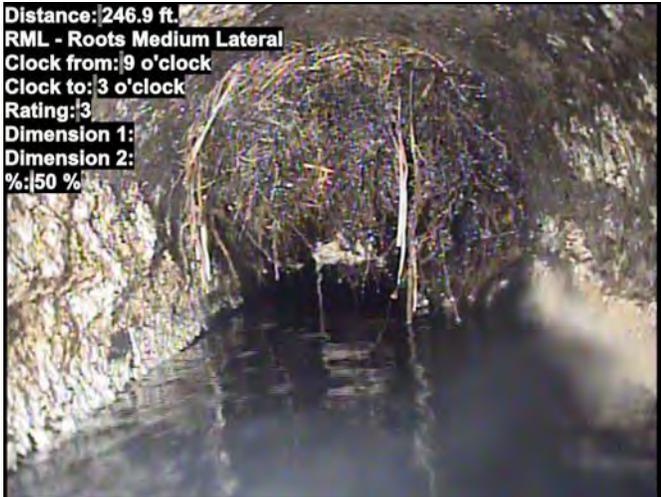
Photo: 14\_013-14\_017-20181116-091541.JPG  
At: 246.9 ft. 9/3 RML - Roots Medium Lateral  
Joint: No 50 %

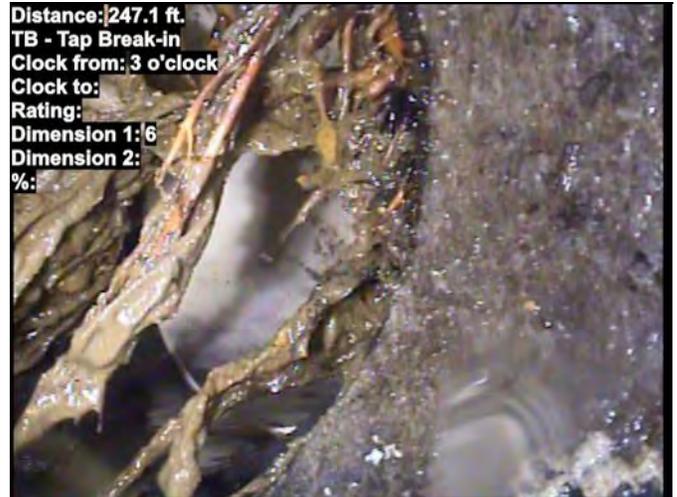
Photo: 14\_013-14\_017-20181116-093734.JPG  
At: 247.1 ft. 3/. TB - Tap Break-in  
Joint: No

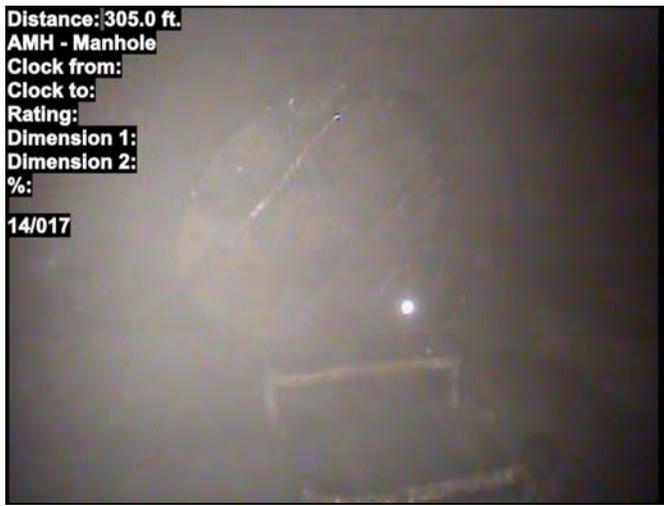
Distance: 305.0 ft.  
AMH - Manhole  
Clock from:  
Clock to:  
Rating:  
Dimension 1:  
Dimension 2:  
%:  
14/017

At: 305 ft. AMH - Manhole

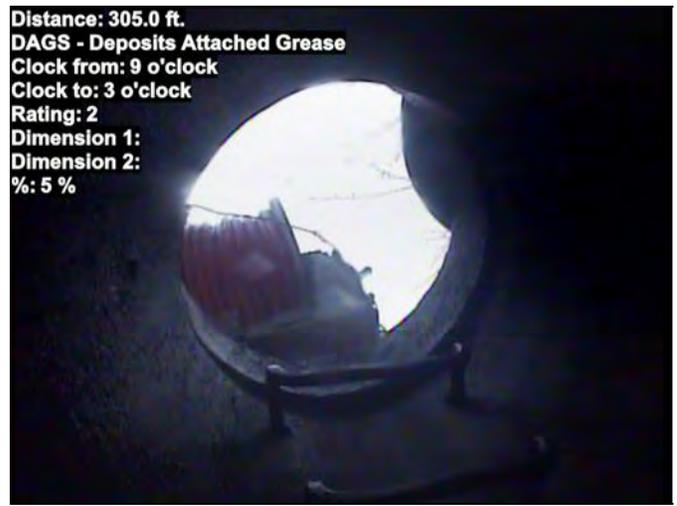
Distance: 305.0 ft.  
DAGS - Deposits Attached Grease  
Clock from: 9 o'clock  
Clock to: 3 o'clock  
Rating: 2  
Dimension 1:  
Dimension 2:  
%: 5 %

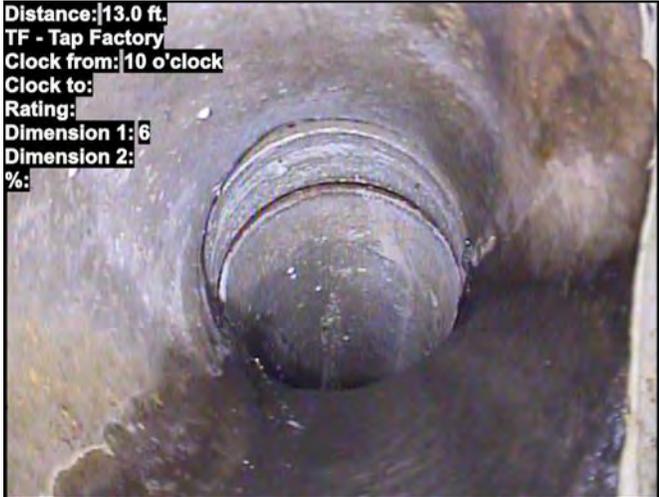
Photo: 14\_020-14\_019-20181116-102457.JPG  
At: 13 ft. 10/. TF - Tap Factory  
Joint: No

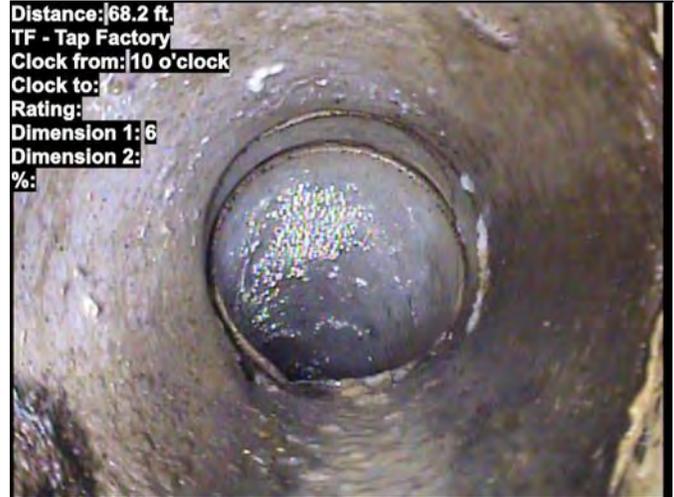
Photo: 14\_020-14\_019-20181116-102638.JPG  
At: 68.2 ft. 10/. TF - Tap Factory  
Joint: No

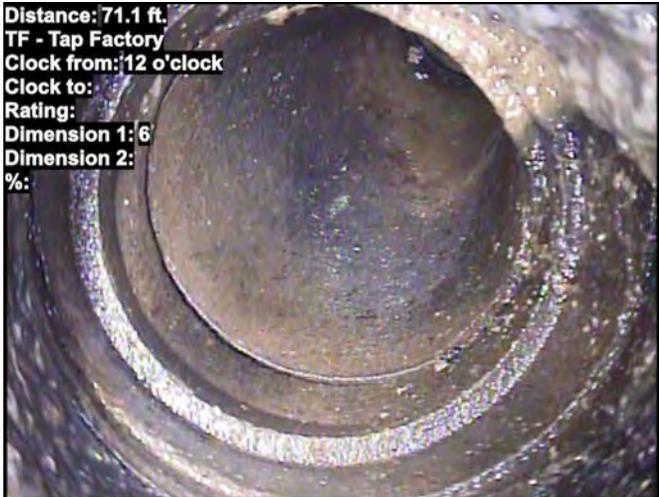
Photo: 14\_020-14\_019-20181116-102659.JPG  
At: 71.1 ft. 12/. TF - Tap Factory  
Joint: No

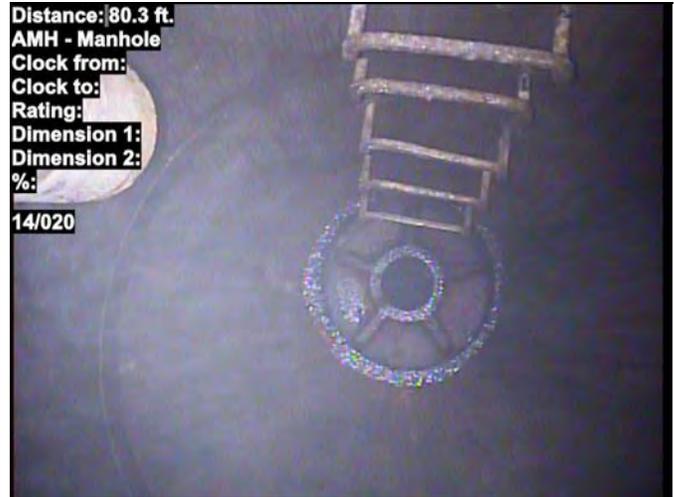
Photo: 14\_020-14\_019-20181116-103040.JPG  
At: 80.3 ft. AMH - Manhole  
Joint: No 14/020

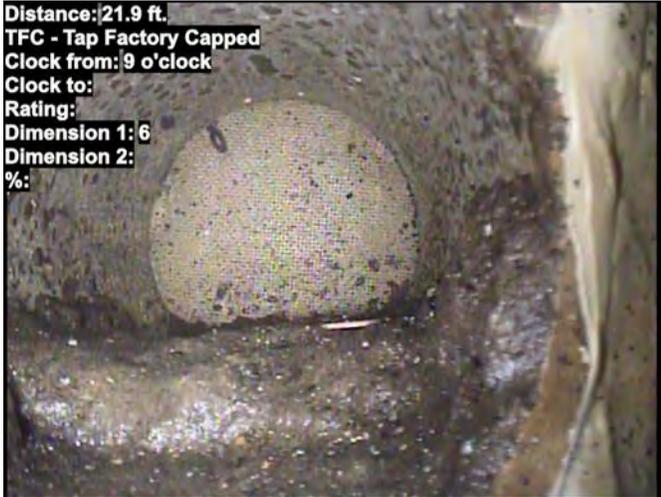
Distance: 21.9 ft.  
TFC - Tap Factory Capped  
Clock from: 9 o'clock  
Clock to:  
Rating:  
Dimension 1: 6  
Dimension 2:  
%:  
Photo: 14\_019-14\_021-20181116-104302.JPG  
At: 21.9 ft. 9/. TFC - Tap Factory Capped  
Joint: No

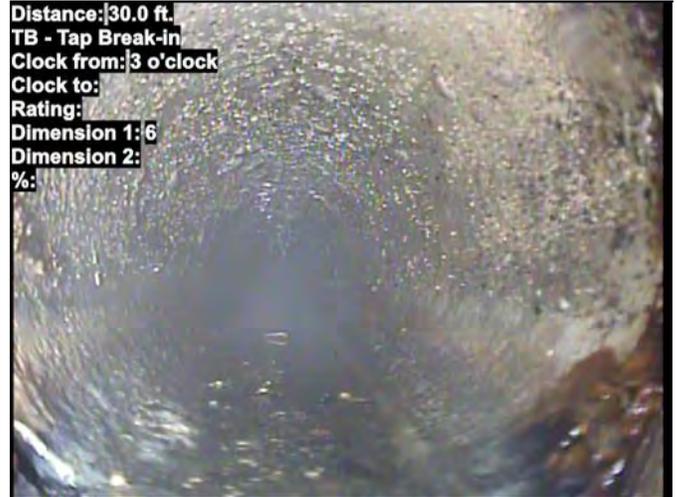
Distance: 30.0 ft.  
TB - Tap Break-in  
Clock from: 3 o'clock  
Clock to:  
Rating:  
Dimension 1: 6  
Dimension 2:  
%:  
Photo: 14\_019-14\_021-20181116-104320.JPG  
At: 30 ft. 3/. TB - Tap Break-in  
Joint: No
