*WESTWOOD SEWER SYSTEM REHABILITATION FIGURES*

**FY19 SEWER SYSTEM REHABILITATION  
 WESTWOOD, MA  
 LOCUS MAP**

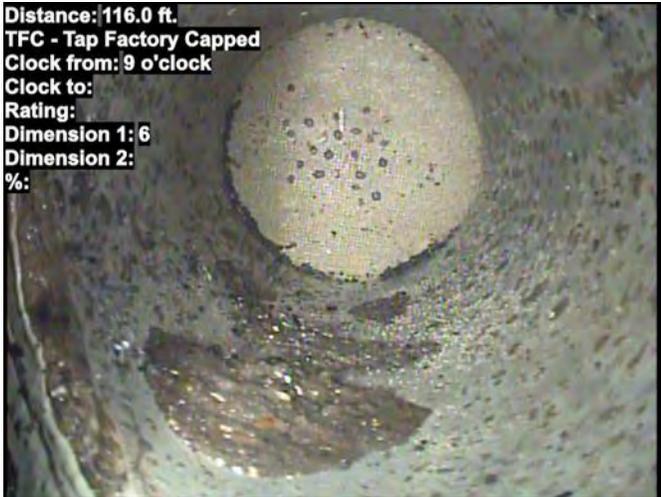
Distance: 116.0 ft.  
TFC - Tap Factory Capped  
Clock from: 9 o'clock  
Clock to:  
Rating:  
Dimension 1: 6  
Dimension 2:  
%:  
Photo: 14\_019-14\_021-20181116-104556.JPG  
At: 116 ft. 9/. TFC - Tap Factory Capped  
Joint: No

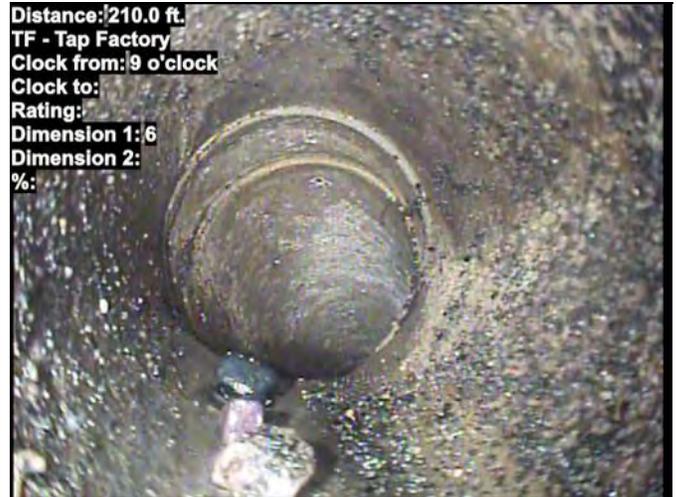
Distance: 210.0 ft.  
TF - Tap Factory  
Clock from: 9 o'clock  
Clock to:  
Rating:  
Dimension 1: 6  
Dimension 2:  
%:  
Photo: 14\_019-14\_021-20181116-104849.JPG  
At: 210 ft. 9/. TF - Tap Factory  
Joint: No

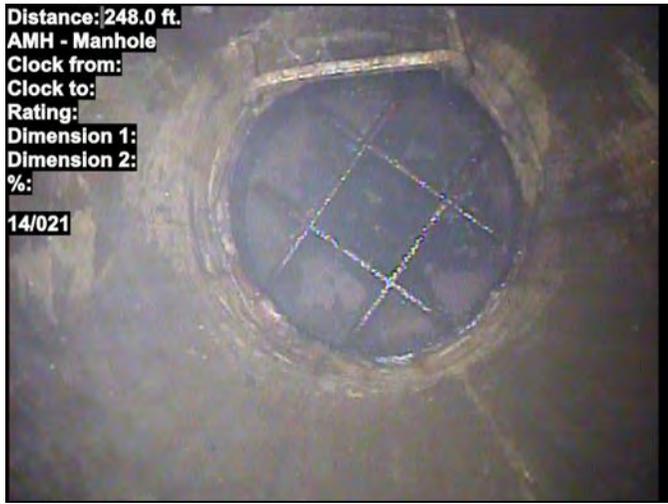
Photo: 14\_019-14\_021-20181116-105004.JPG

At: 248 ft. AMH - Manhole

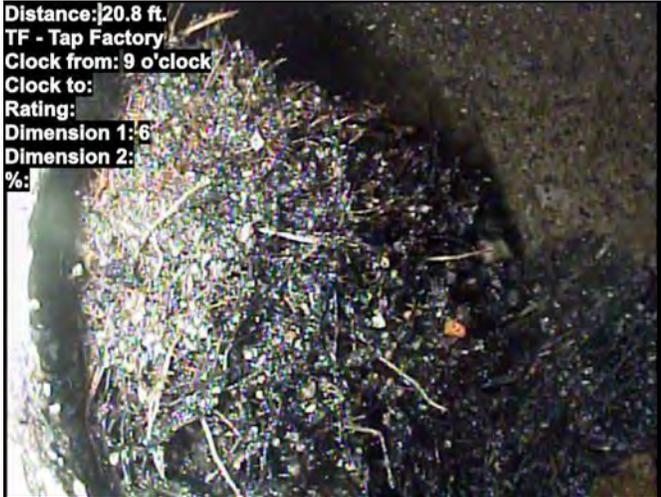
Photo: 14\_021-14\_022-20181116-105611.JPG  
At: 20.8 ft. 9/. TF - Tap Factory  
Joint: No

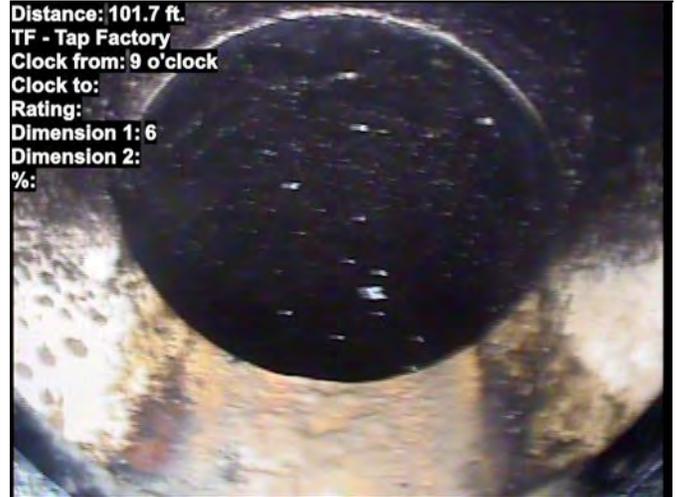
Photo: 14\_021-14\_022-20181116-105823.JPG  
At: 101.7 ft. 9/. TF - Tap Factory  
Joint: No

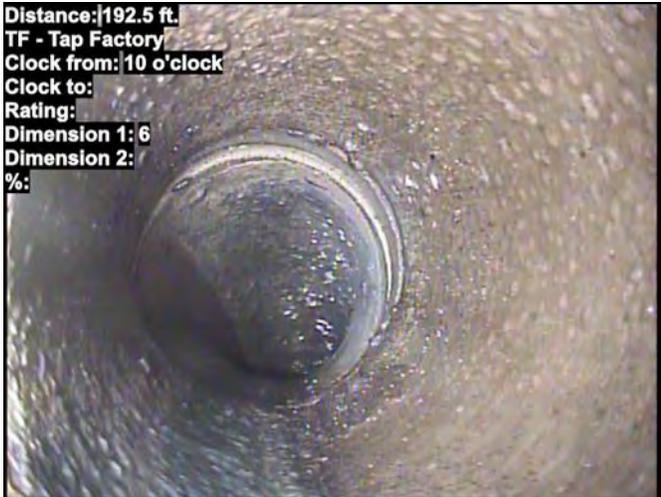
Photo: 14\_021-14\_022-20181116-110121.JPG  
At: 192.5 ft. 10/. TF - Tap Factory  
Joint: No

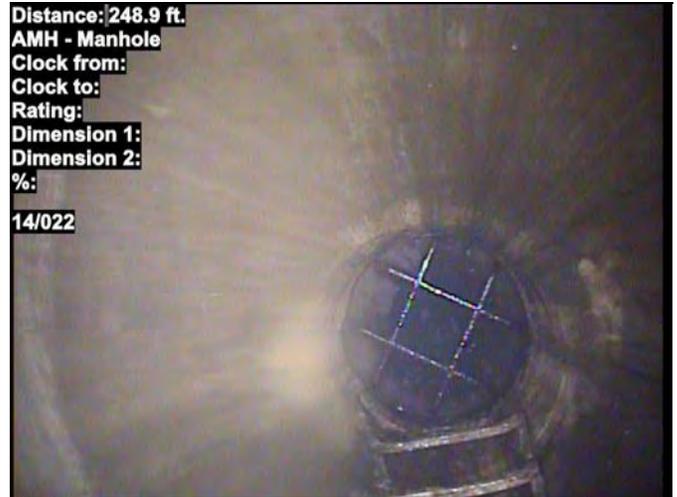
Photo: 14\_021-14\_022-20181116-110410.JPG  
At: 248.9 ft. AMH - Manhole  
Joint: No 14/022

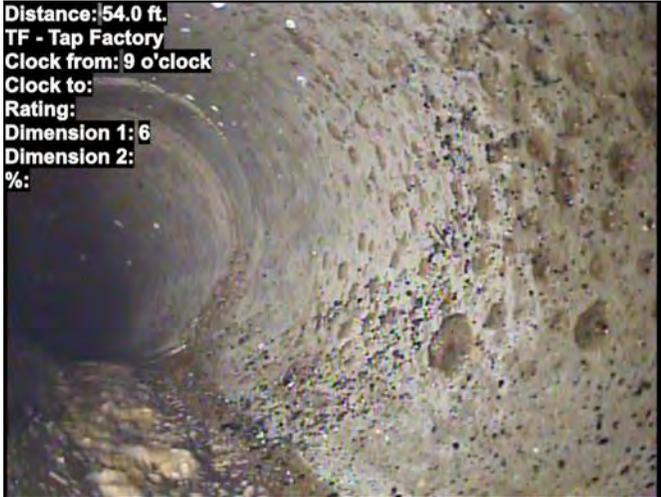
Distance: 54.0 ft.  
TF - Tap Factory  
Clock from: 9 o'clock  
Clock to:  
Rating:  
Dimension 1: 6  
Dimension 2:  
%:  
Photo: 14\_017-14\_018-20181116-112030.JPG  
At: 54 ft. 9/. TF - Tap Factory  
Joint: No

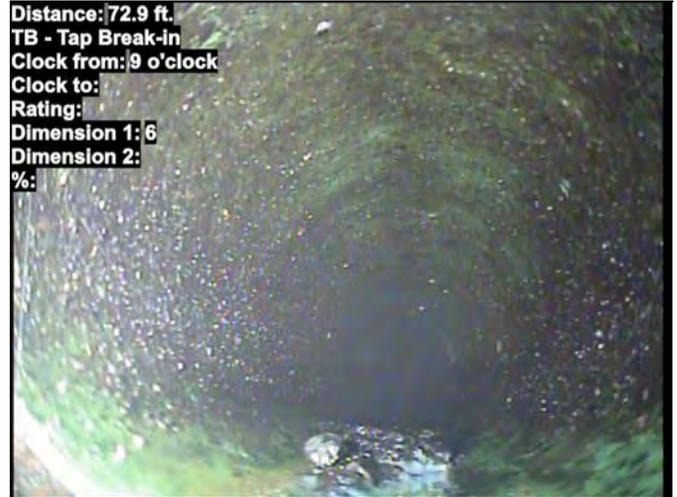
Distance: 72.9 ft.  
TB - Tap Break-in  
Clock from: 9 o'clock  
Clock to:  
Rating:  
Dimension 1: 6  
Dimension 2:  
%:  
Photo: 14\_017-14\_018-20181116-112112.JPG  
At: 72.9 ft. 9/. TB - Tap Break-in  
Joint: No

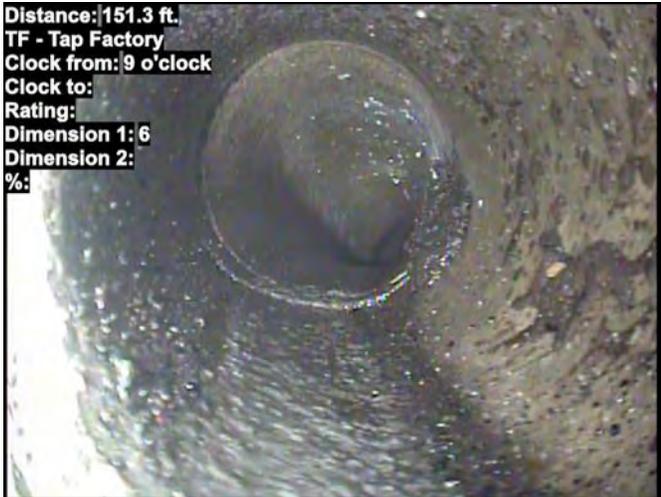
Distance: 151.3 ft.  
TF - Tap Factory  
Clock from: 9 o'clock  
Clock to:  
Rating:  
Dimension 1: 6  
Dimension 2:  
%:  
Photo: 14\_017-14\_018-20181116-112350.JPG  
At: 151.3 ft. 9/. TF - Tap Factory  
Joint: No

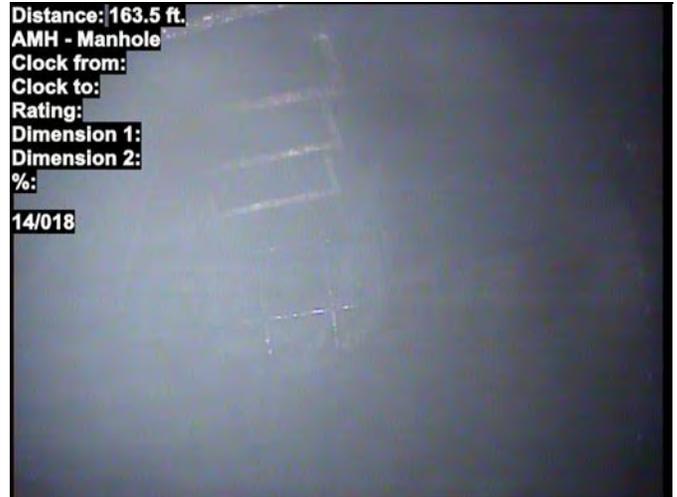
Distance: 163.5 ft.  
AMH - Manhole  
Clock from:  
Clock to:  
Rating:  
Dimension 1:  
Dimension 2:  
%:  
14/018  
Photo: 14\_017-14\_018-20181116-112443.JPG  
At: 163.5 ft. AMH - Manhole  
Joint: No 14/018

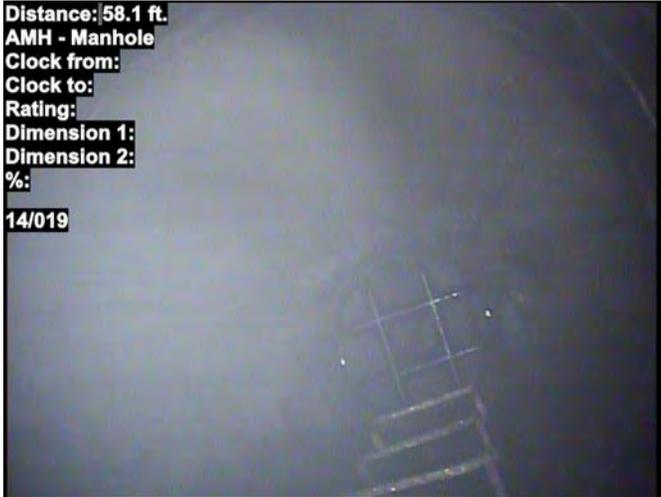
Photo: 14\_018-14\_019-20181116-113217.JPG

At: 58.1 ft. AMH - Manhole

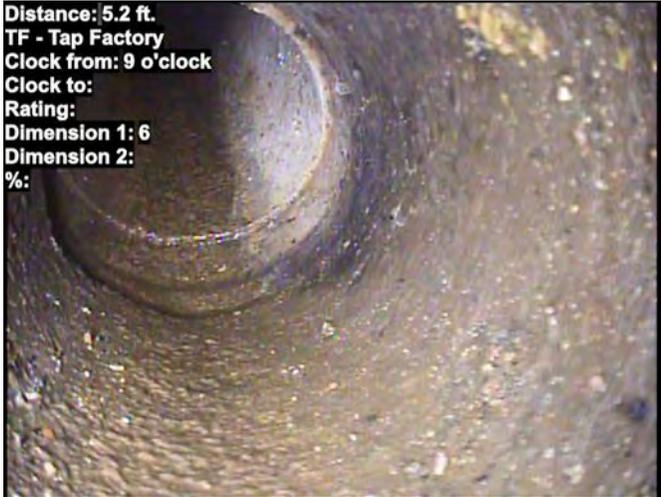
Photo: 14\_070-14\_071-20181116-115427.JPG  
At: 5.2 ft. 9/. TF - Tap Factory  
Joint: No

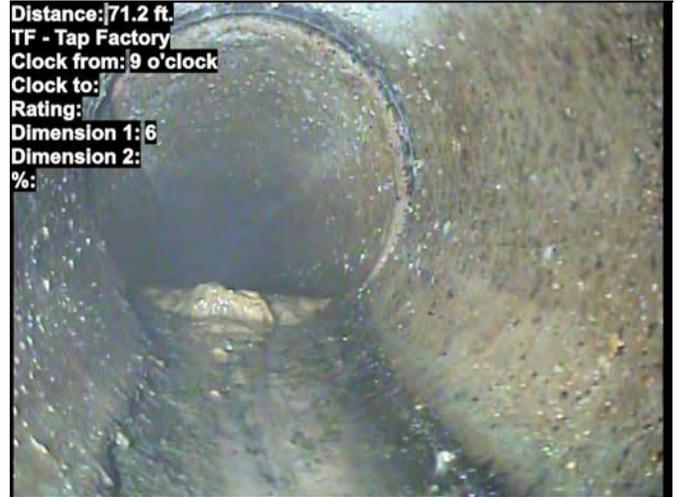
Photo: 14\_070-14\_071-20181116-115613.JPG  
At: 71.2 ft. 9/. TF - Tap Factory  
Joint: No

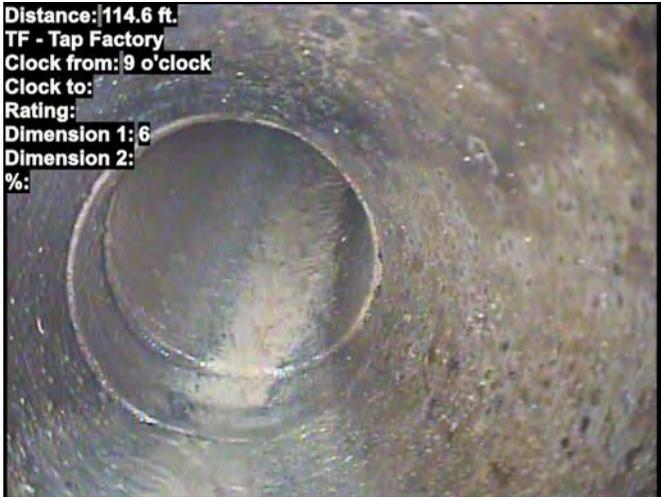
Photo: 14\_070-14\_071-20181116-115742.JPG  
At: 114.6 ft. 9/. TF - Tap Factory  
Joint: No

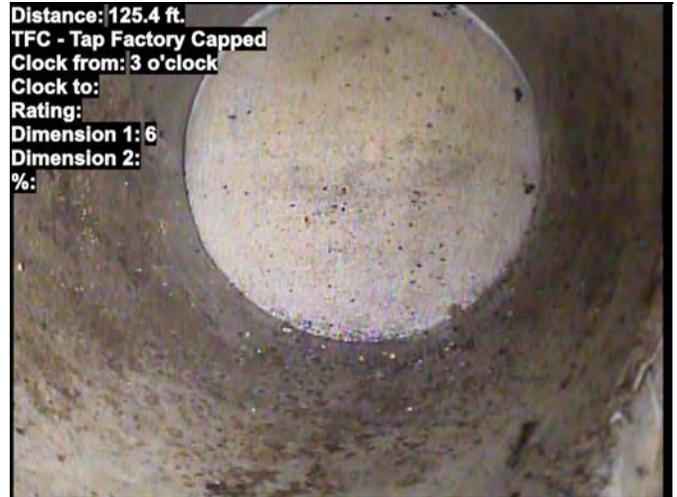
Photo: 14\_070-14\_071-20181116-115817.JPG  
At: 125.4 ft. 3/. TFC - Tap Factory Capped  
Joint: No

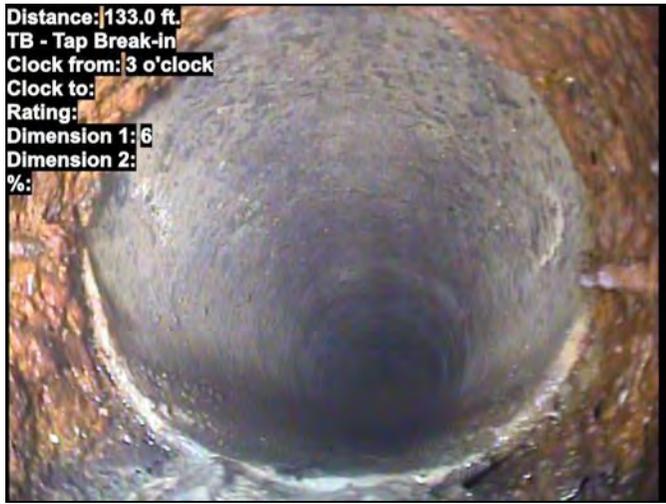
Distance: 133.0 ft.  
TB - Tap Break-in  
Clock from: 3 o'clock  
Clock to:  
Rating:  
Dimension 1: 6  
Dimension 2:  
%:

Photo: 14\_070-14\_071-20181116-115834.JPG  
At: 133 ft. 3/. TB - Tap Break-in  
Joint: No

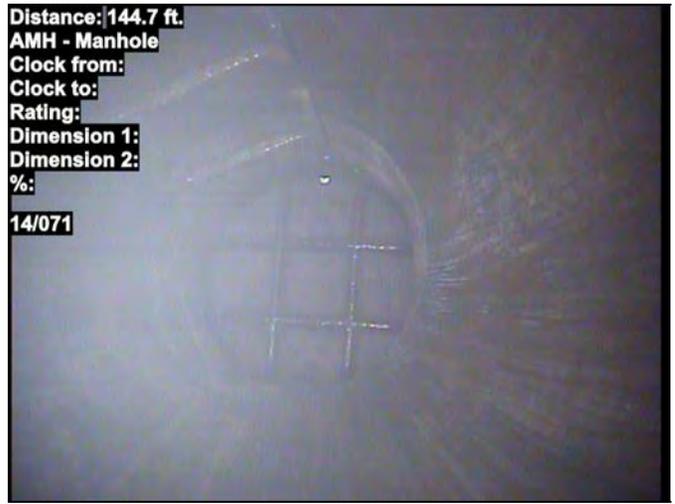
Distance: 144.7 ft.  
AMH - Manhole  
Clock from:  
Clock to:  
Rating:  
Dimension 1:  
Dimension 2:  
%:

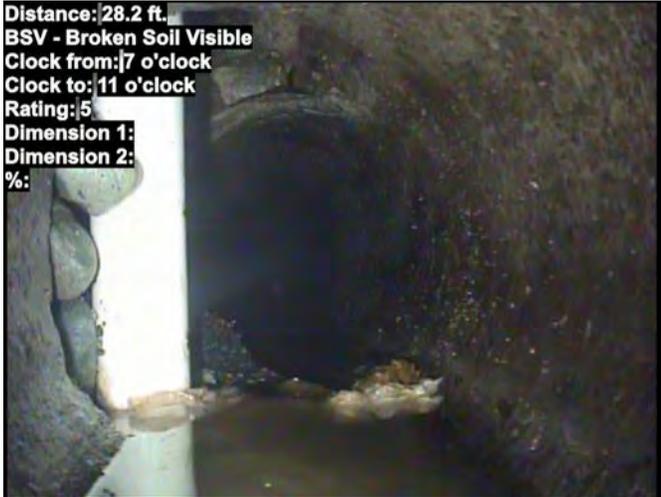
Photo: 14\_071-14\_013-20181116-120243.JPG  
At: 28.2 ft. 7/11 BSV - Broken Soil Visible  
Joint: No

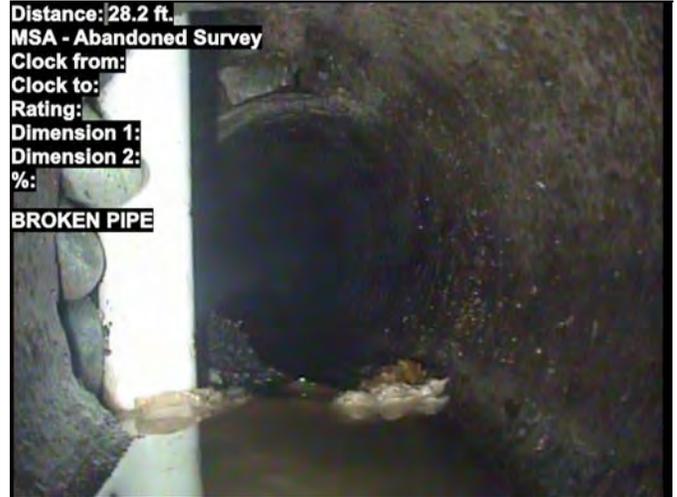
Photo: 14\_071-14\_013-20181116-120319.JPG  
At: 28.2 ft. MSA - Abandoned Survey  
Joint: No **BROKEN PIPE**

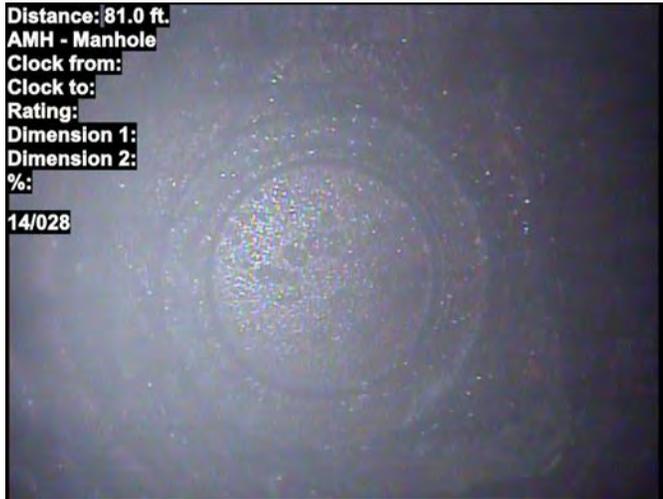
Photo: 14\_029-14\_028-20181116-123235.JPG

At: 81 ft. AMH - Manhole

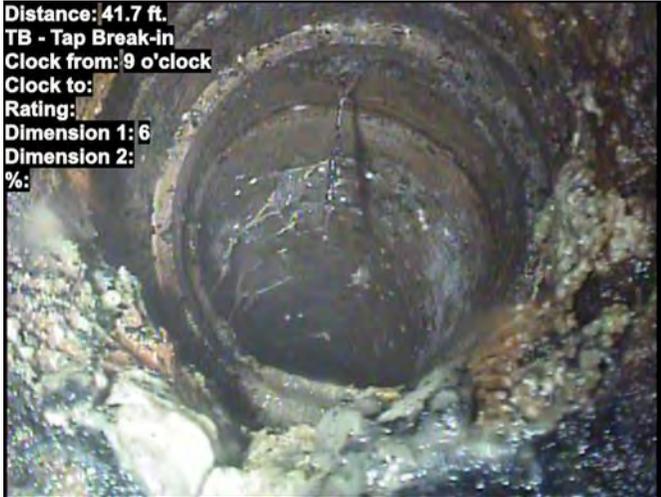
Photo: 14\_028-14\_043-20181116-123842.JPG  
At: 41.7 ft. 9/. TB - Tap Break-in  
Joint: No

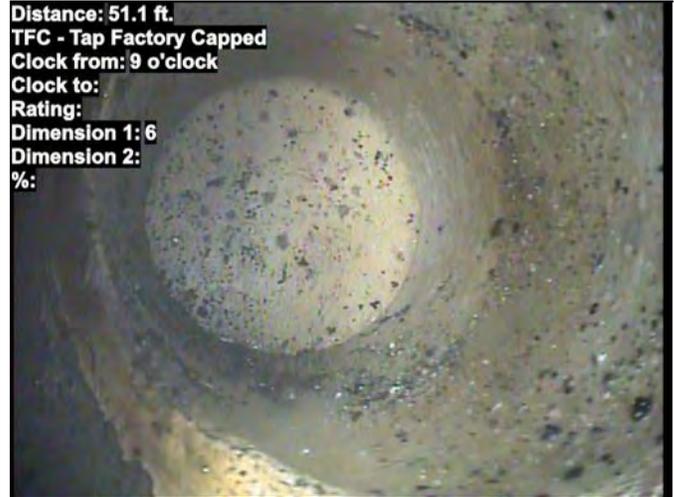
Photo: 14\_028-14\_043-20181116-123909.JPG  
At: 51.1 ft. 9/. TFC - Tap Factory Capped  
Joint: No

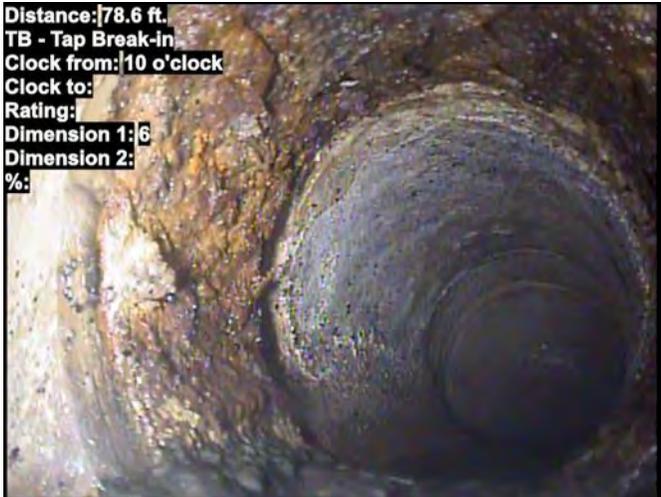
Photo: 14\_028-14\_043-20181116-124010.JPG  
At: 78.6 ft. 10/. TB - Tap Break-in  
Joint: No

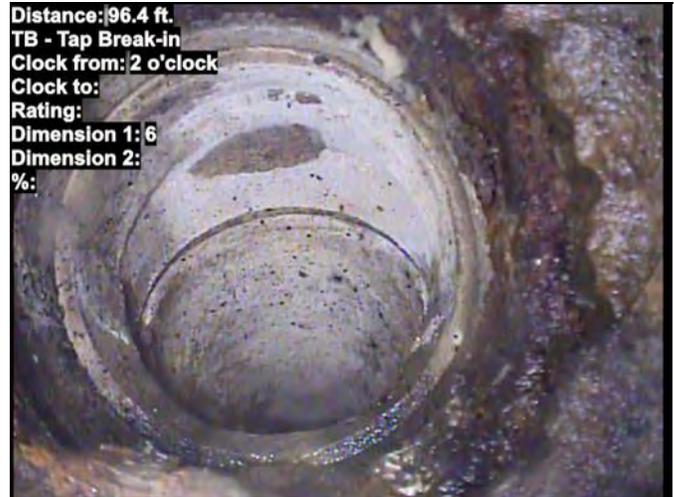
Photo: 14\_028-14\_043-20181116-124117.JPG  
At: 96.4 ft. 2/. TB - Tap Break-in  
Joint: No

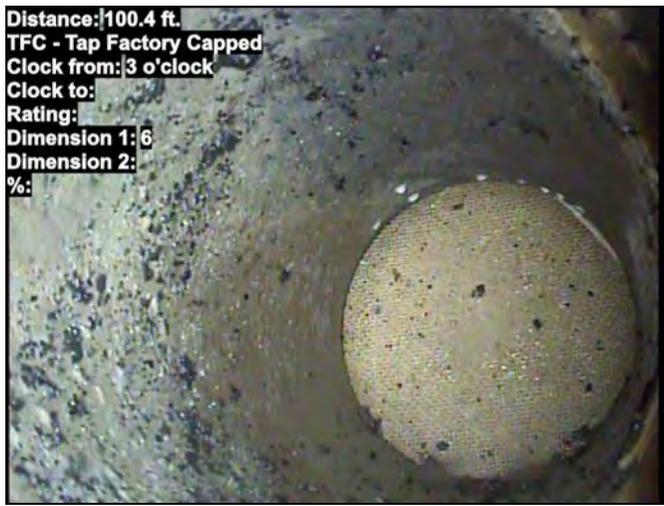
Distance: 100.4 ft.  
TFC - Tap Factory Capped  
Clock from: 3 o'clock  
Clock to:  
Rating:  
Dimension 1: 6  
Dimension 2: 6  
%:  
Photo: 14\_028-14\_043-20181116-124140.JPG  
At: 100.4 ft. 3/. TFC - Tap Factory Capped  
Joint: No

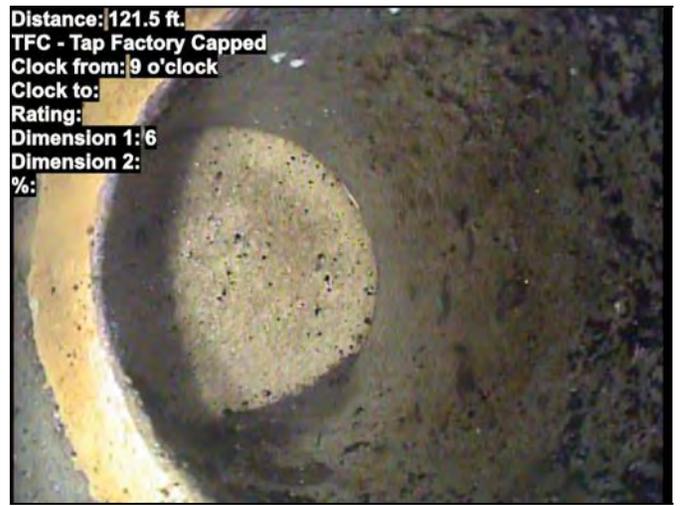
Distance: 121.5 ft.  
TFC - Tap Factory Capped  
Clock from: 9 o'clock  
Clock to:  
Rating:  
Dimension 1: 6  
Dimension 2: 6  
%:  
Photo: 14\_028-14\_043-20181116-124332.JPG  
At: 121.5 ft. 9/. TFC - Tap Factory Capped  
Joint: No

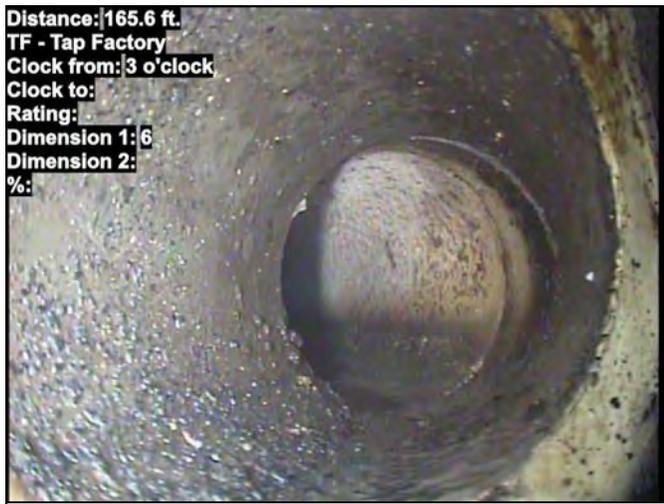
Distance: 165.6 ft.  
TF - Tap Factory  
Clock from: 3 o'clock  
Clock to:  
Rating:  
Dimension 1: 6  
Dimension 2: 6  
%:  
Photo: 14\_028-14\_043-20181116-124504.JPG  
At: 165.6 ft. 3/. TF - Tap Factory  
Joint: No

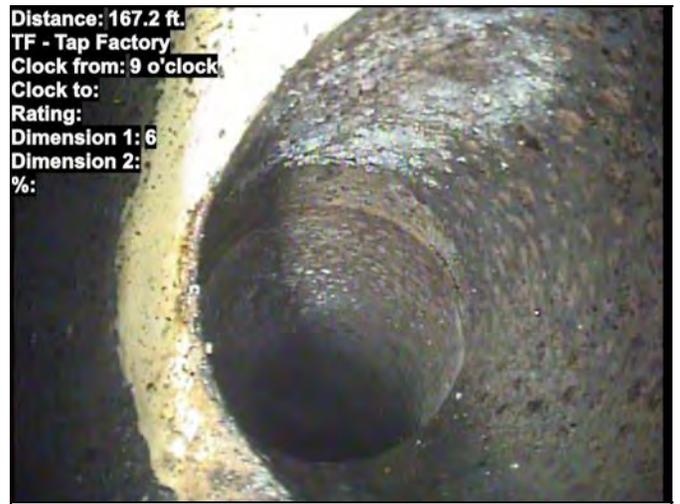
Distance: 167.2 ft.  
TF - Tap Factory  
Clock from: 9 o'clock  
Clock to:  
Rating:  
Dimension 1: 6  
Dimension 2: 6  
%:  
Photo: 14\_028-14\_043-20181116-124513.JPG  
At: 167.2 ft. 9/. TF - Tap Factory  
Joint: No

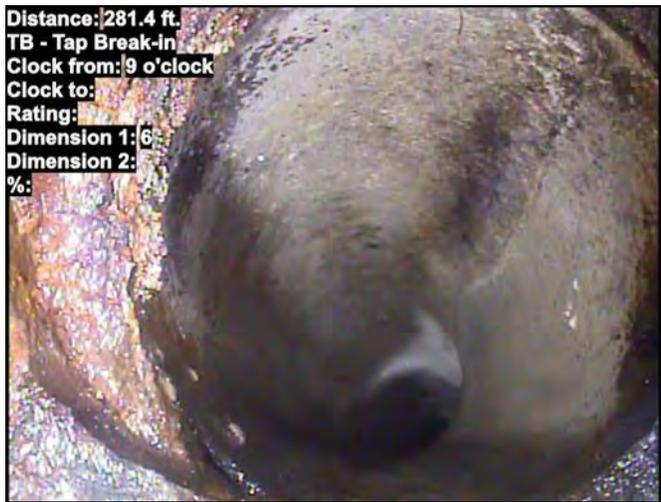
Distance: 281.4 ft.  
TB - Tap Break-in  
Clock from: 9 o'clock  
Clock to:  
Rating:  
Dimension 1: 6  
Dimension 2:  
%:  
Photo: 14\_043-14\_044-20181116-132251.JPG  
At: 281.4 ft. 9/. TB - Tap Break-in  
Joint: No

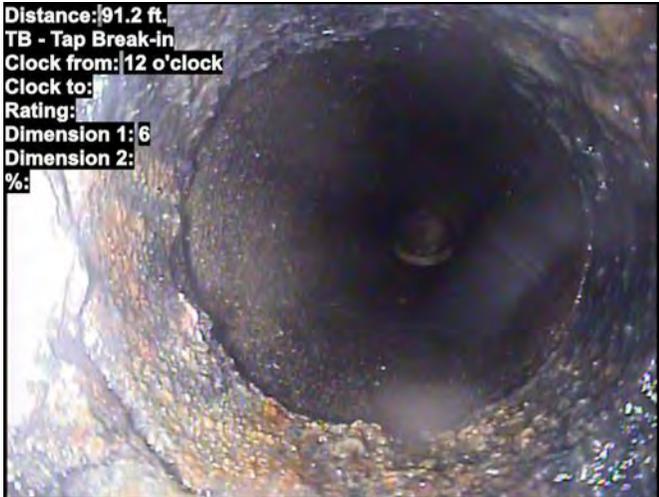
Photo: 14\_045-14\_046-20181116-134346.JPG  
At: 91.2 ft. 12/. TB - Tap Break-in  
Joint: No

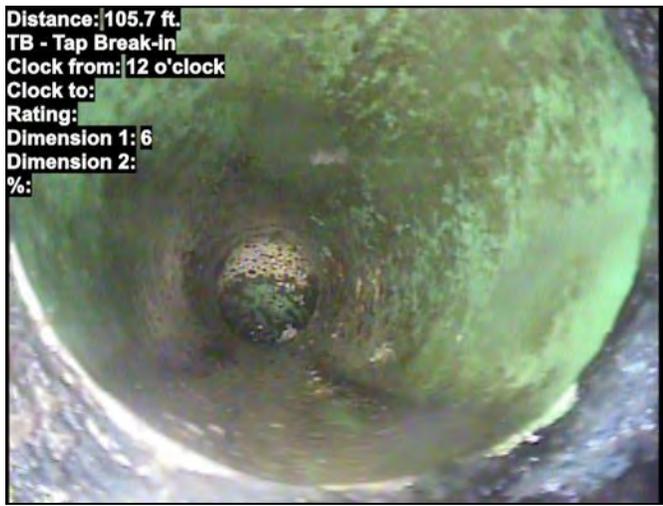
Distance: 105.7 ft.  
TB - Tap Break-in  
Clock from: 12 o'clock  
Clock to:  
Rating:  
Dimension 1: 6  
Dimension 2:  
%:  
Photo: 14\_045-14\_046-20181116-134435.JPG  
At: 105.7 ft. 12/. TB - Tap Break-in  
Joint: No

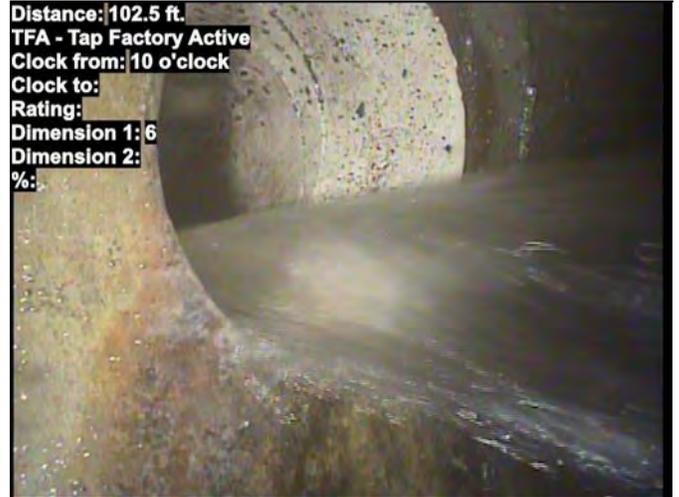
Photo: 10\_028-10\_029-20181119-080524.JPG  
At: 102.5 ft. 10/. TFA - Tap Factory Active  
Joint: No

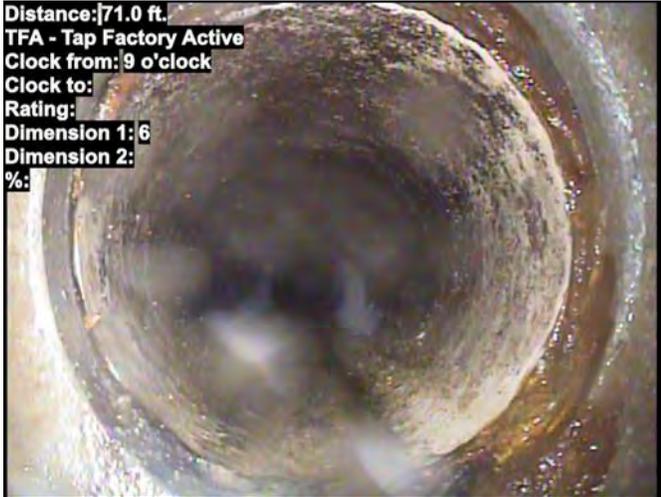
Distance: 71.0 ft.  
TFA - Tap Factory Active  
Clock from: 9 o'clock  
Clock to:  
Rating:  
Dimension 1: 6  
Dimension 2:  
%:

Photo: 10\_029-10\_030-20181119-082446.JPG  
At: 71 ft. 9/. TFA - Tap Factory Active  
Joint: No

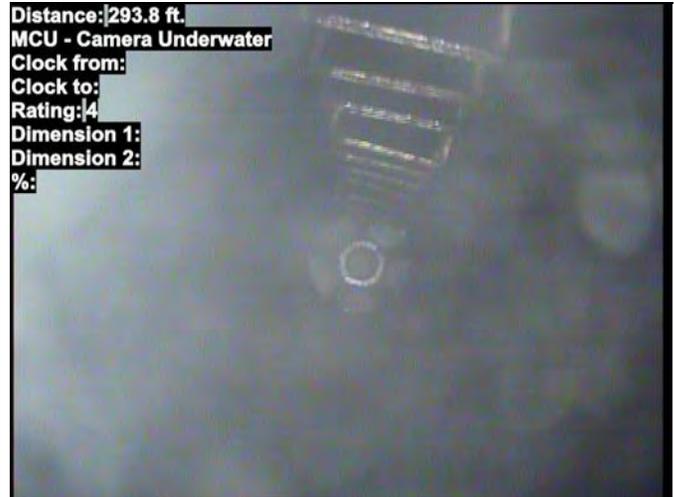
Distance: 293.8 ft.  
MCU - Camera Underwater  
Clock from:  
Clock to:  
Rating: 4  
Dimension 1:  
Dimension 2:  
%:

Photo: 10\_029-10\_030-20181119-084049.JPG  
At: 293.8 ft. MCU - Camera Underwater  
Joint: No

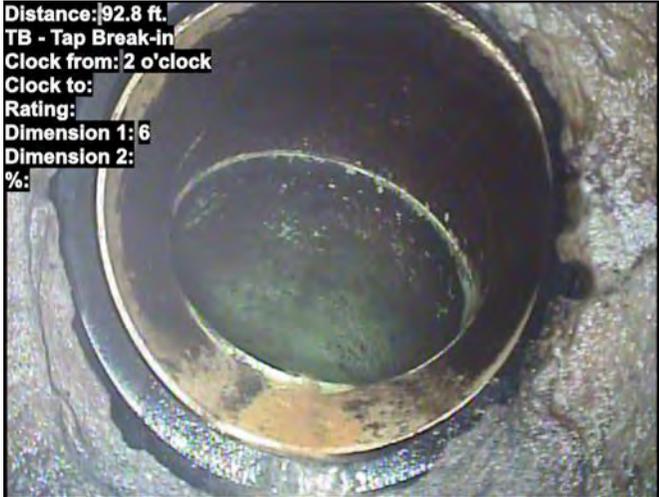
Photo: 10\_039-10\_043-20181119-095052.JPG  
At: 92.8 ft. 2/. TB - Tap Break-in  
Joint: No

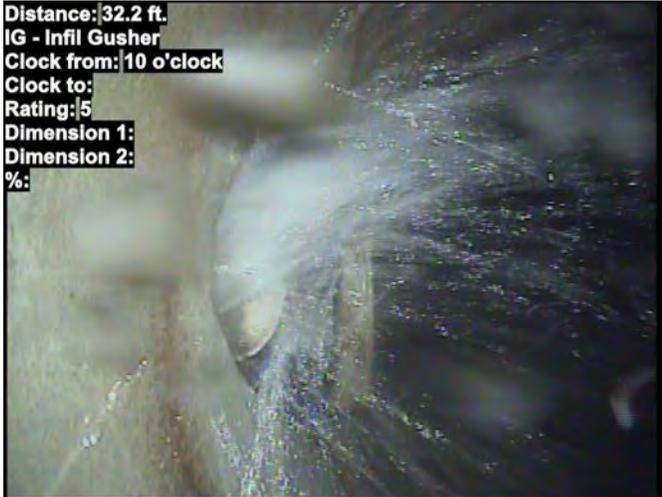
Distance: 32.2 ft.  
IG - Infil Gusher  
Clock from: 10 o'clock  
Clock to:  
Rating: 5  
Dimension 1:  
Dimension 2:  
%:  
Photo: 10\_043-10\_044-20181119-095654.JPG  
At: 32.2 ft. 10/. IG - Infil Gusher  
Joint: No

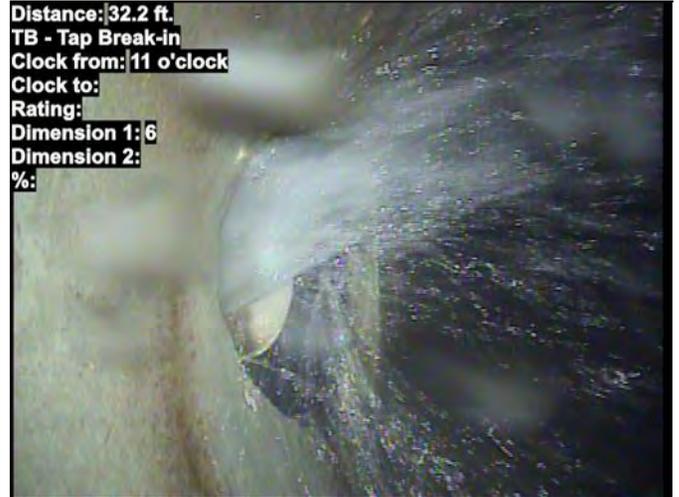
Distance: 32.2 ft.  
TB - Tap Break-in  
Clock from: 11 o'clock  
Clock to:  
Rating:  
Dimension 1: 6  
Dimension 2:  
%:  
Photo: 10\_043-10\_044-20181119-095647.JPG  
At: 32.2 ft. 11/. TB - Tap Break-in  
Joint: No

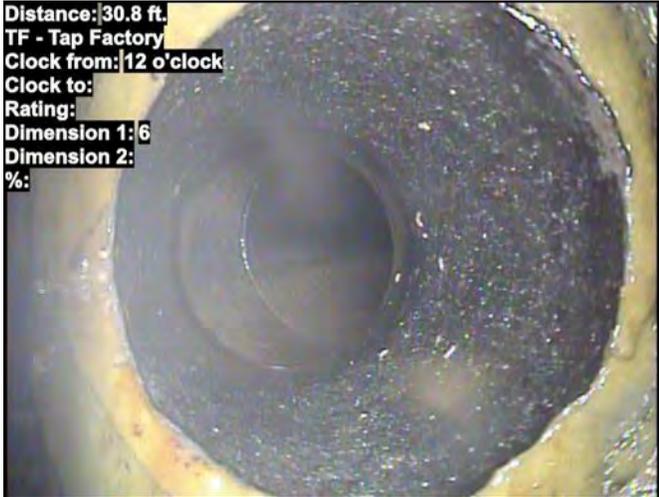
Distance: 30.8 ft.  
TF - Tap Factory  
Clock from: 12 o'clock  
Clock to:  
Rating:  
Dimension 1: 6  
Dimension 2:  
%:  
Photo: 10\_044-10-045-20181119-100417.JPG  
At: 30.8 ft. 12/. TF - Tap Factory  
Joint: No

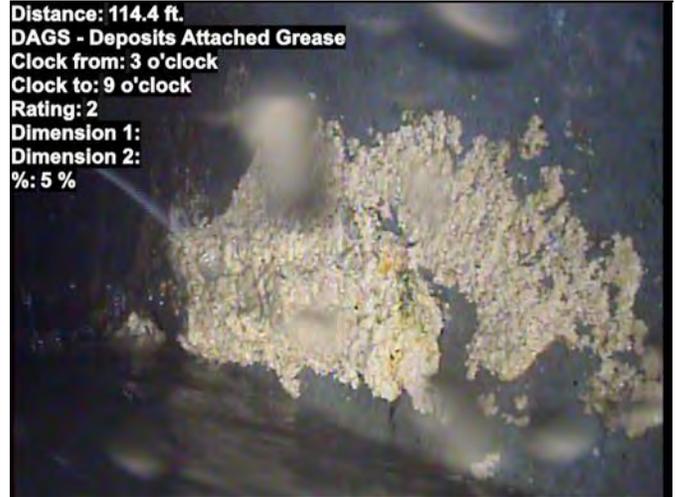
Distance: 114.4 ft.  
DAGS - Deposits Attached Grease  
Clock from: 3 o'clock  
Clock to: 9 o'clock  
Rating: 2  
Dimension 1:  
Dimension 2:  
%: 5 %  
Photo: 10\_044-10-045-20181119-100637.JPG  
At: 114.4 ft. 3/9 DAGS - Deposits Attached Grease  
Joint: No 5 %

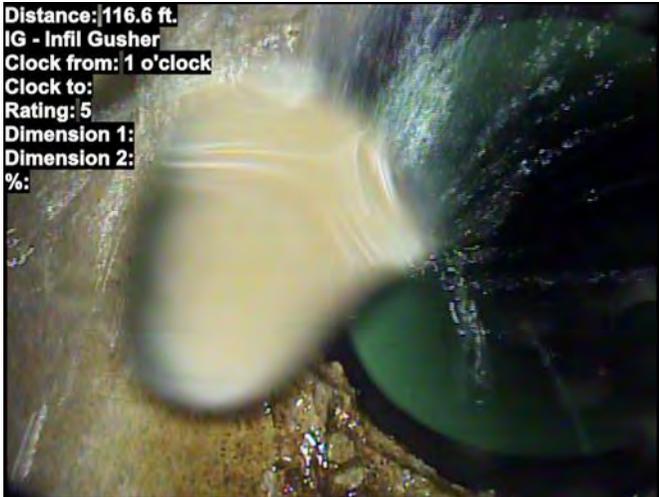
Distance: 116.6 ft.  
IG - Infil Gusher  
Clock from: 1 o'clock  
Clock to:  
Rating: 5  
Dimension 1:  
Dimension 2:  
%:  
Photo: 10\_044-10-045-20181119-100705.JPG  
At: 116.6 ft. 1/. IG - Infil Gusher  
Joint: No

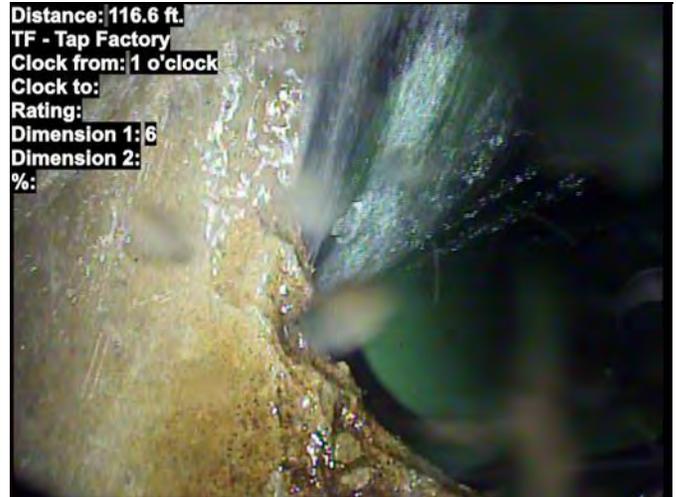
Distance: 116.6 ft.  
TF - Tap Factory  
Clock from: 1 o'clock  
Clock to:  
Rating:  
Dimension 1: 6  
Dimension 2:  
%:  
Photo: 10\_044-10-045-20181119-100659.JPG  
At: 116.6 ft. 1/. TF - Tap Factory  
Joint: No

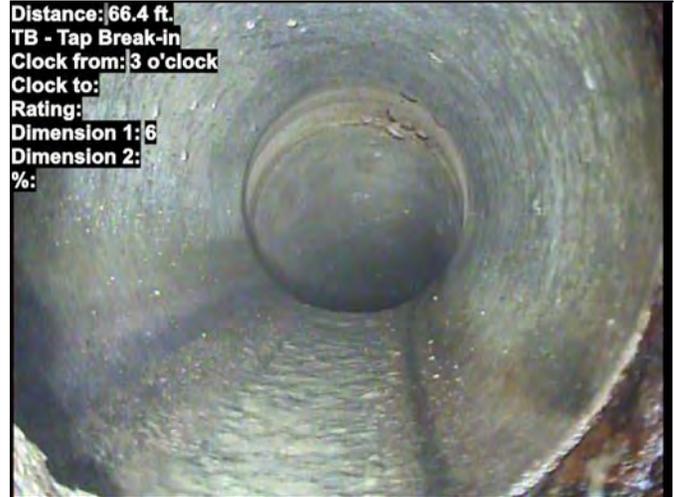
Photo: 08\_030-08\_029-20181119-113855.JPG  
At: 66.4 ft. 3/. TB - Tap Break-in  
Joint: No

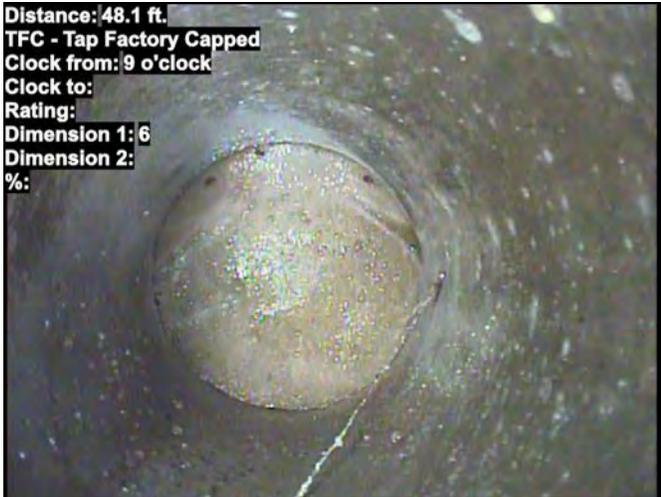
Photo: 08\_029-08\_028-20181119-115020.JPG  
At: 48.1 ft. 9/. TFC - Tap Factory Capped  
Joint: No

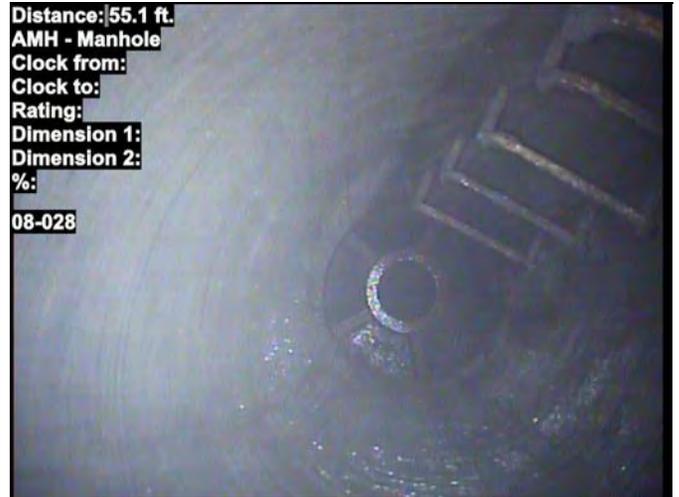
Photo: 08\_029-08\_028-20181119-115130.JPG  
At: 55.1 ft. AMH - Manhole  
Joint: No 08-028

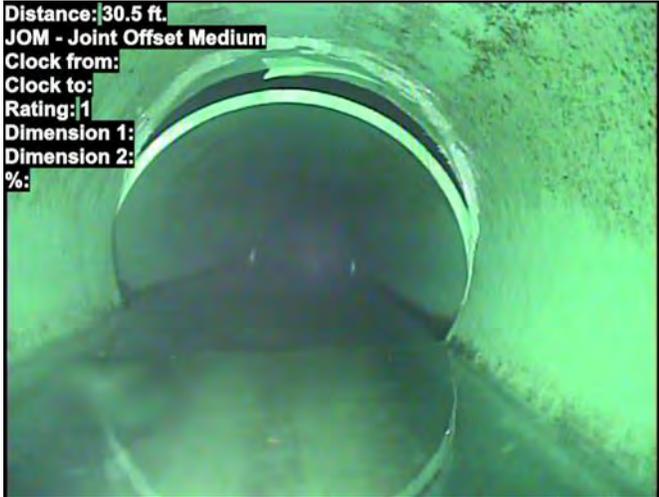
Distance: 30.5 ft.  
JOM - Joint Offset Medium  
Clock from:  
Clock to:  
Rating: 1  
Dimension 1:  
Dimension 2:  
%:

Photo: 10\_070A-10\_070-20181119-130811.JPG  
At: 30.5 ft. JOM - Joint Offset Medium  
Joint: No

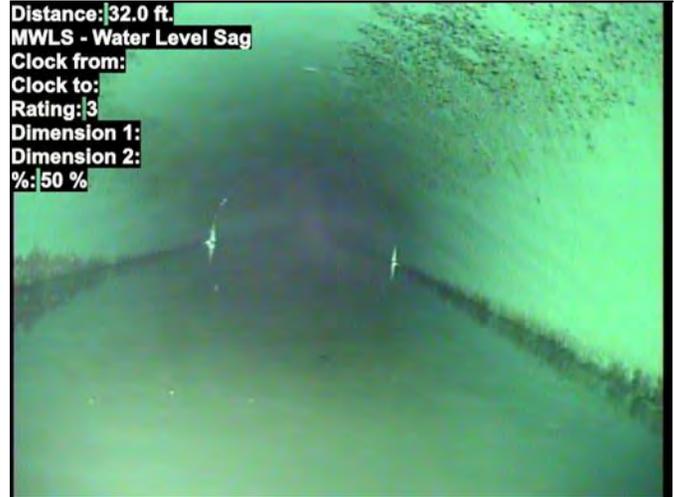
Distance: 32.0 ft.  
MWLS - Water Level Sag  
Clock from:  
Clock to:  
Rating: 3  
Dimension 1:  
Dimension 2:  
%: 50 %

Photo: 10\_070A-10\_070-20181119-130834.JPG  
At: 32 ft. MWLS - Water Level Sag  
Joint: No 50 %

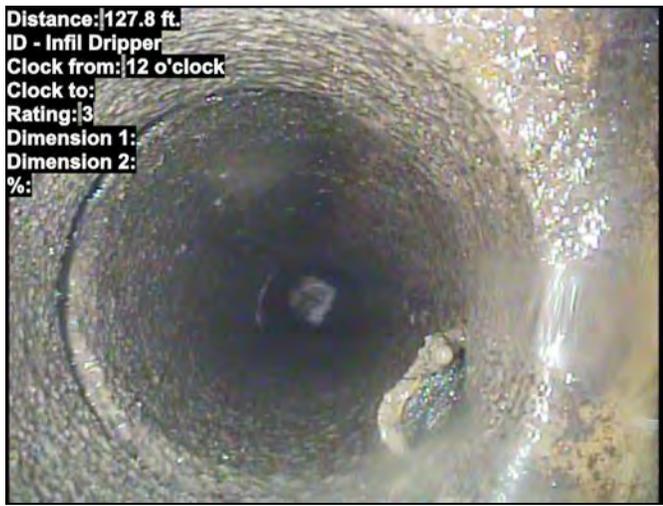
Distance: 127.8 ft.  
ID - Infil Dripper  
Clock from: 12 o'clock  
Clock to:  
Rating: 3  
Dimension 1:  
Dimension 2:  
%:  
Photo: 14\_047-10\_048-20181120-075224.JPG  
At: 127.8 ft. 12/. ID - Infil Dripper  
Joint: No

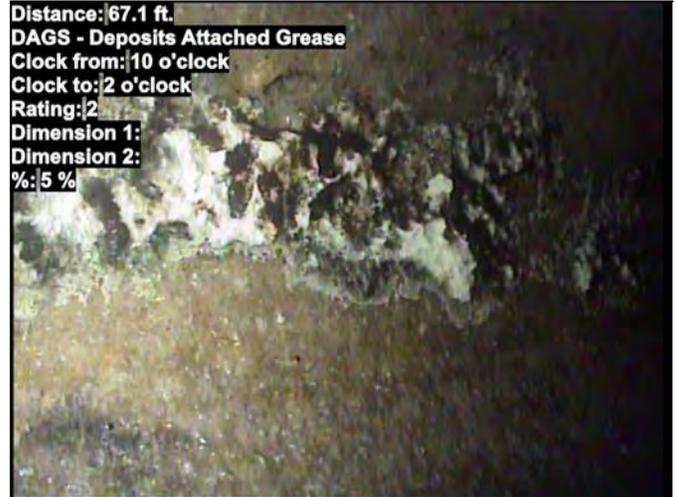
Photo: 14\_049-14\_072-20181120-091139.JPG  
At: 67.1 ft. 10/2 DAGS - Deposits Attached Grease  
Joint: No 5 %

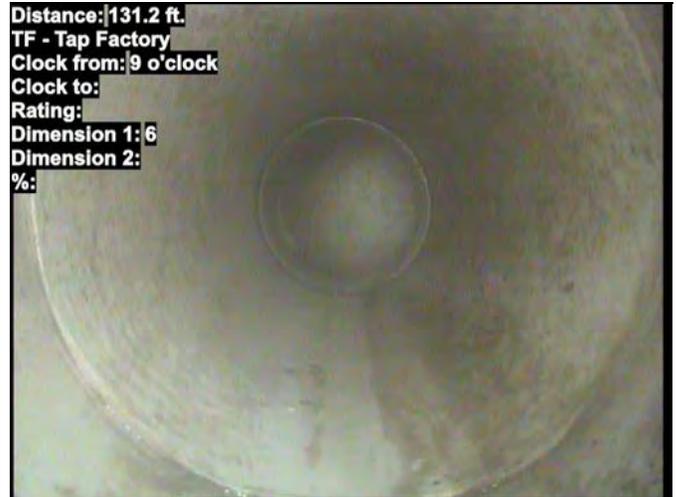
At: 131.2 ft. 9/. TF - Tap Factory

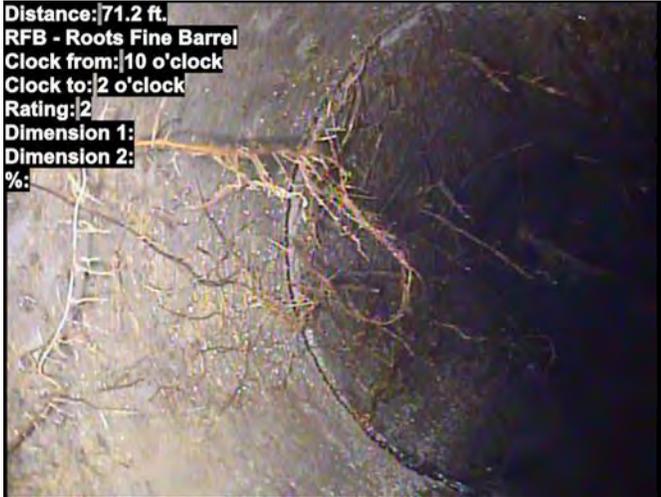
Photo: 14\_025-14\_061-20181120-111242.JPG  
At: 71.2 ft. 10/2 RFB - Roots Fine Barrel  
Joint: No

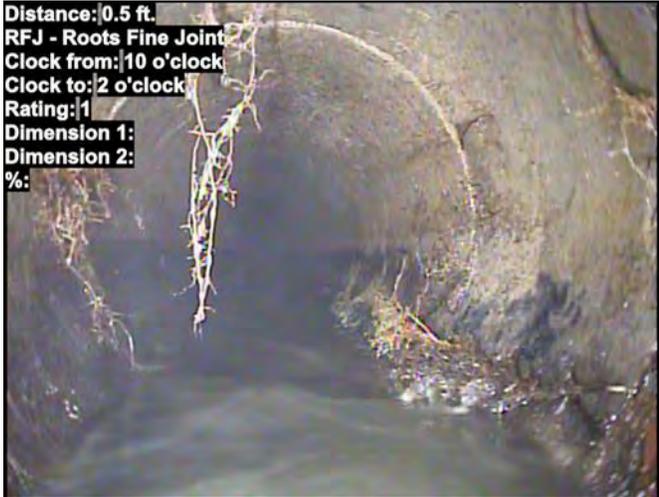
Photo: 14\_061-14\_026-20181120-111450.JPG  
At: 0.5 ft. 10/2 RFJ - Roots Fine Joint  
Joint: Yes

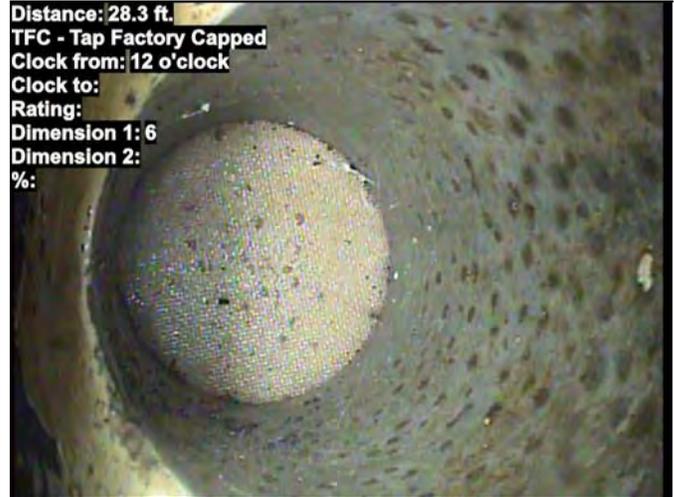
Photo: 14\_061-14\_026-20181120-111557.JPG  
At: 28.3 ft. 12/. TFC - Tap Factory Capped  
Joint: No

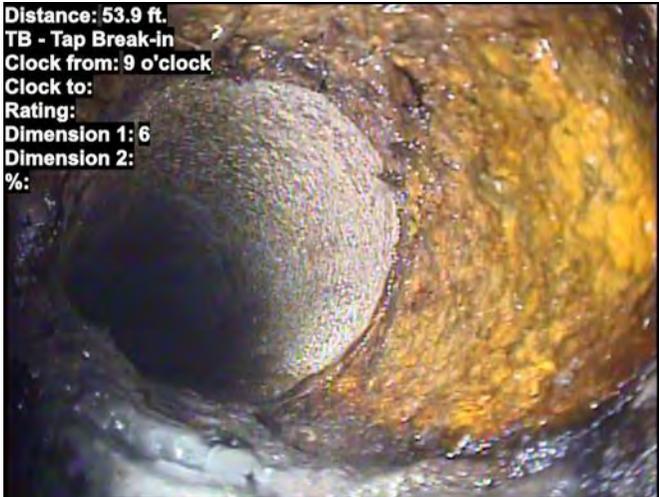
Photo: 14\_061-14\_026-20181120-111708.JPG  
At: 53.9 ft. 9/. TB - Tap Break-in  
Joint: No

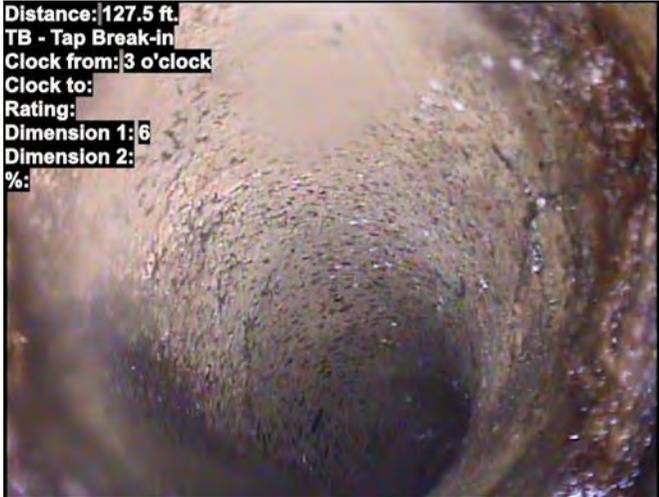
Photo: 14\_027-14\_028-20181120-114439.JPG  
At: 127.5 ft. 3/. TB - Tap Break-in  
Joint: No

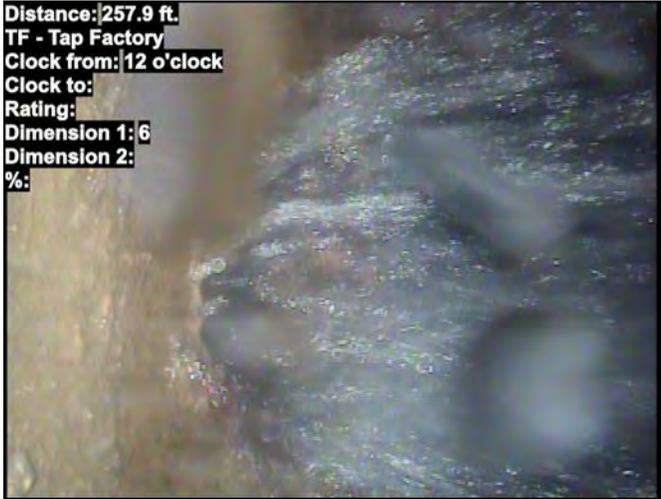
Photo: 18\_107-17\_058-20181121-090320.JPG  
At: 257.9 ft. 12/. TF - Tap Factory  
Joint: No

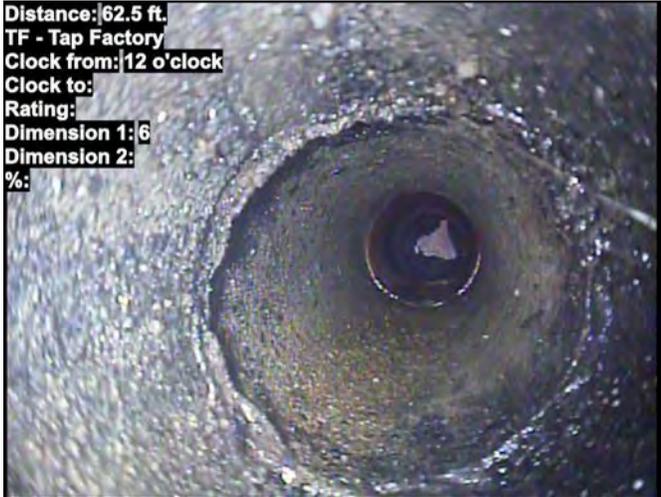
At: 62.5 ft. 12/. TF - Tap Factory

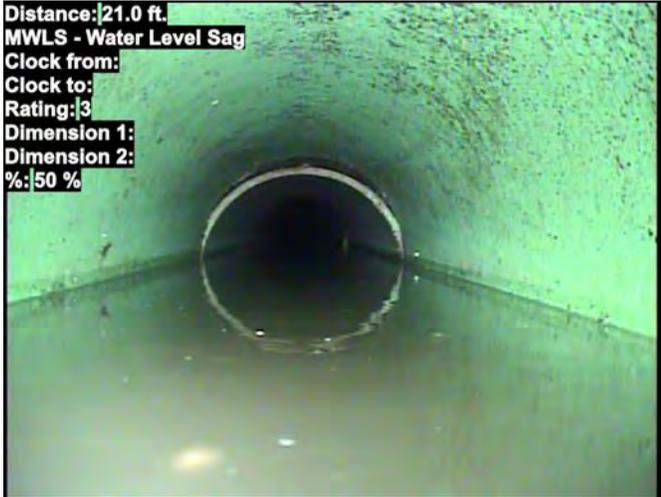
Photo: 10\_070A-10\_070-20181115-092723.JPG  
At: 21 ft. MWLS - Water Level Sag  
Joint: No 50 %

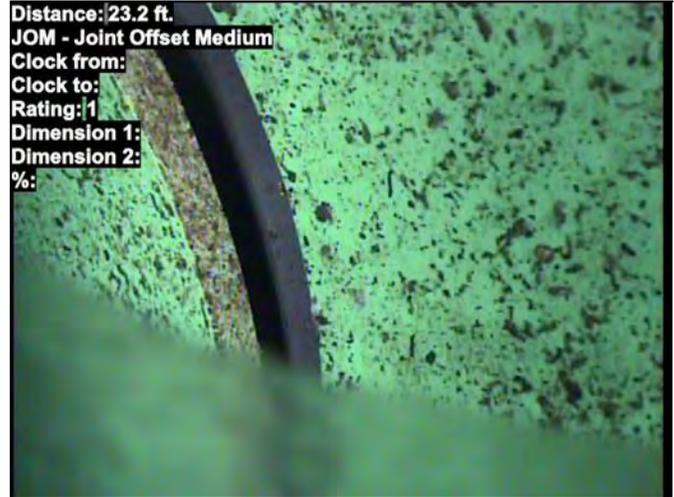
Photo: 10\_070A-10\_070-20181115-092752.JPG  
At: 23.2 ft. JOM - Joint Offset Medium  
Joint: No

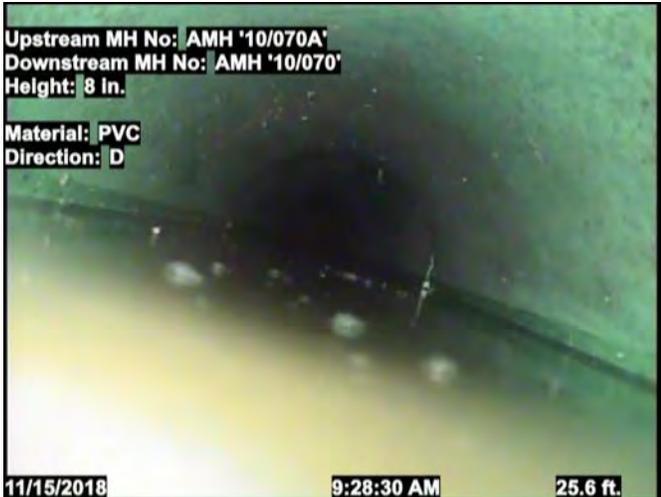
Photo: 10\_070A-10\_070-20181115-100101.JPG  
At: 25.6 ft. MSA - Abandoned Survey  
Joint: No Survey Abandoned

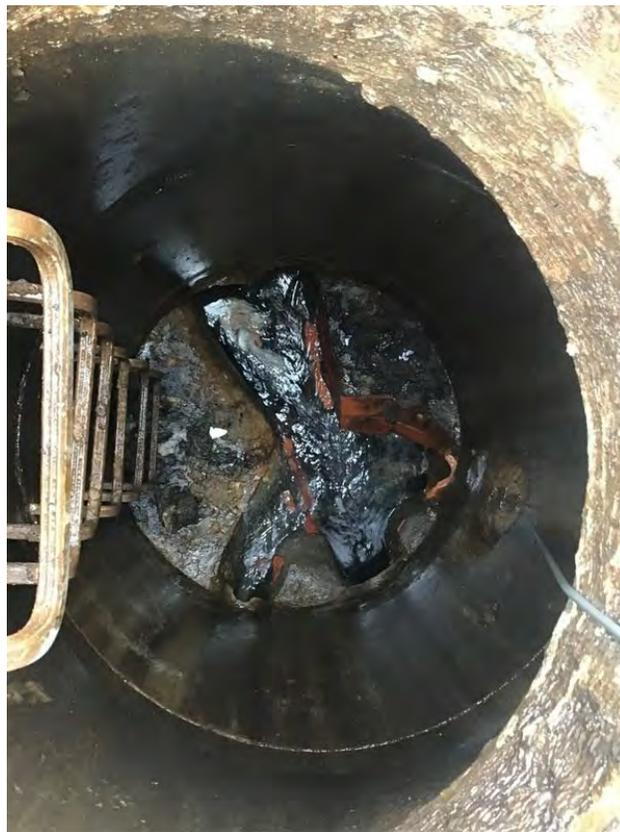
Defect Type	Infiltration, Runner, Barrel
Location	Bench
Defect Depth Start	8.33
Defect Clock Start	1
Defect Comment	Crack in brick of bench that water is coming out of
Additional Comments	Brick bench is overall in poor condition
