*WESTWOOD SEWER SYSTEM REHABILITATION FIGURES*

**FY19 SEWER SYSTEM REHABILITATION  
 WESTWOOD, MA  
 LOCUS MAP**

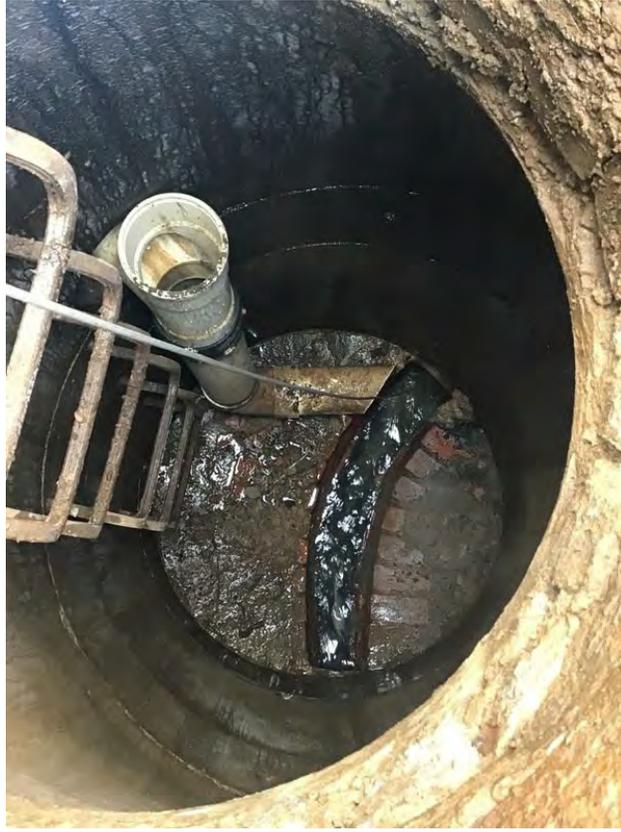
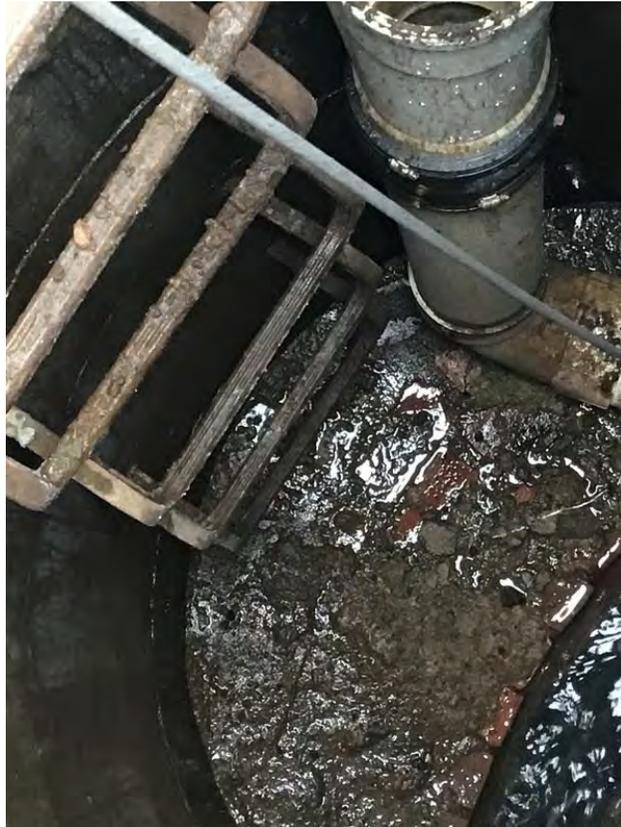
Defect Type	Infiltration, Runner, Barrel
Location	Bench
Defect Depth Start	8.08
Defect Clock Start	2
Defect Comment	Leaking where wall meets bench

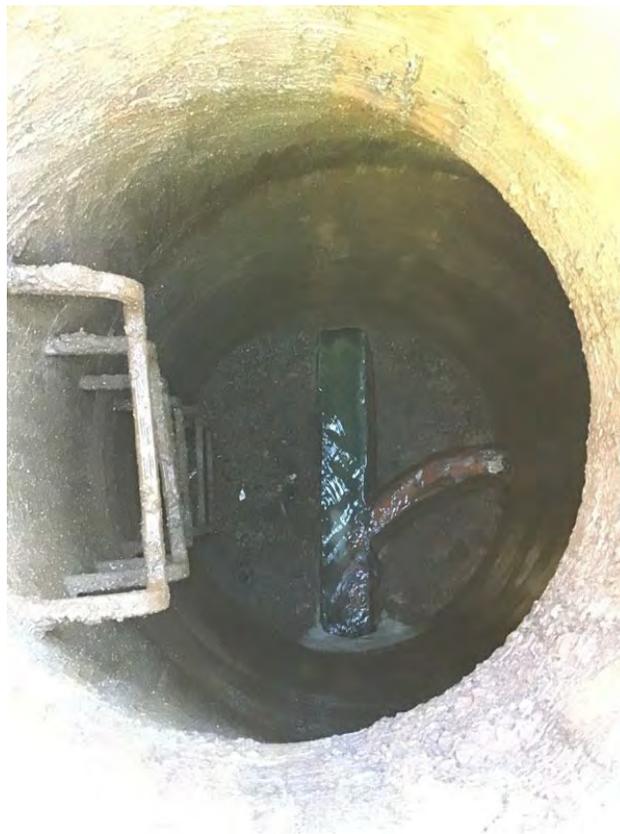
## 10/020

Defect Type	Infiltration, Dripper, Connection
Location	Channel
Defect Depth Start	8.83
Defect Clock Start	3
Defect Comment	Infiltration at pipe from Russell Ave, detected with cctv

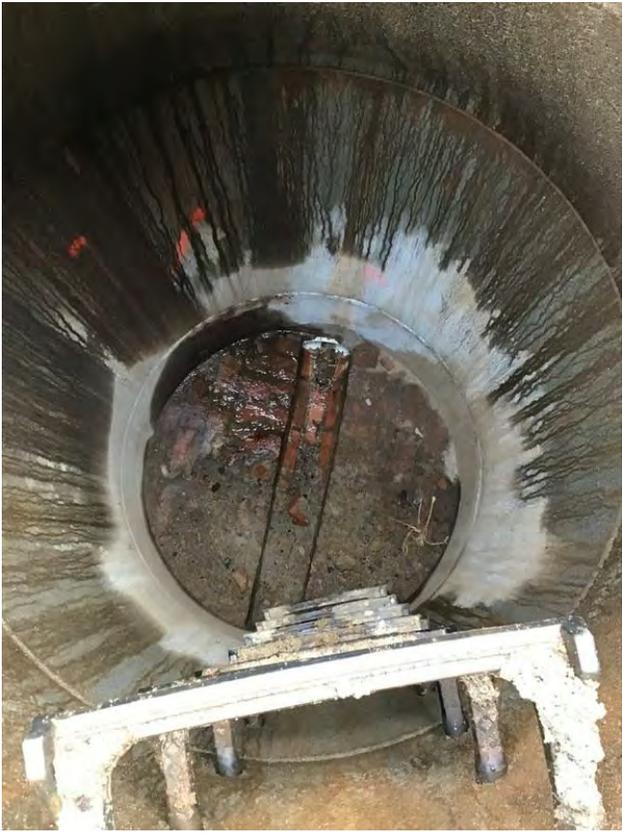
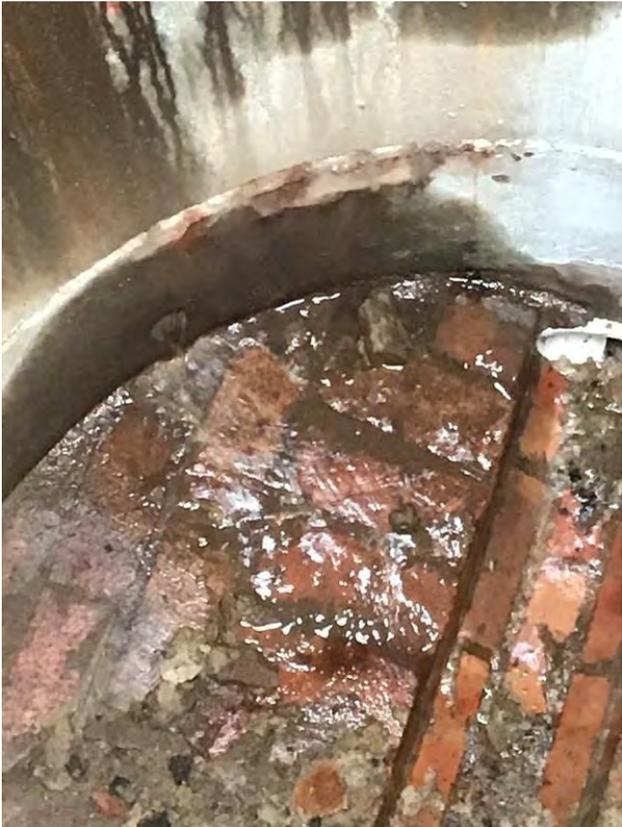
## 12/116

Defect Type	Hole, Void Visible
Location	Wall
Defect Depth Start	8.67
Defect Clock Start	5
Defect Comment	Water consistently flowing out 1" hole

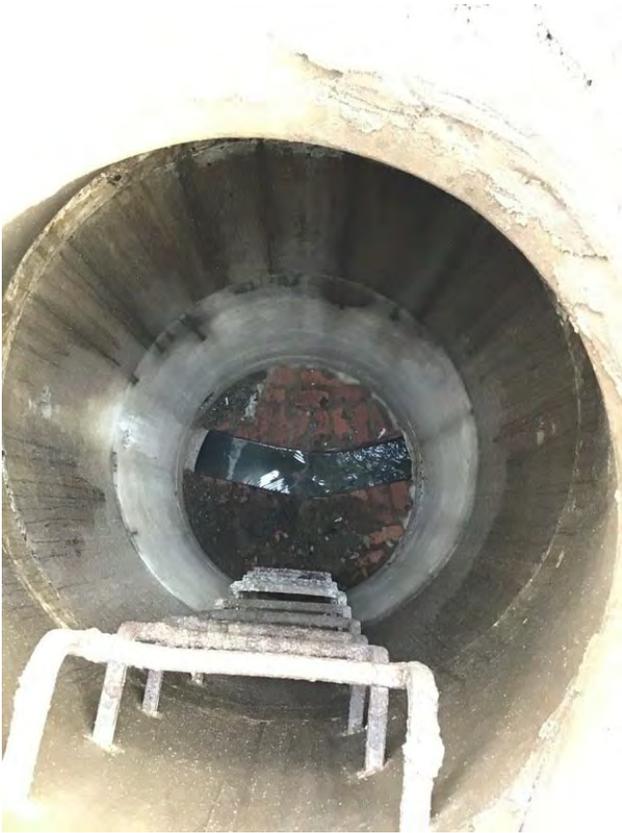
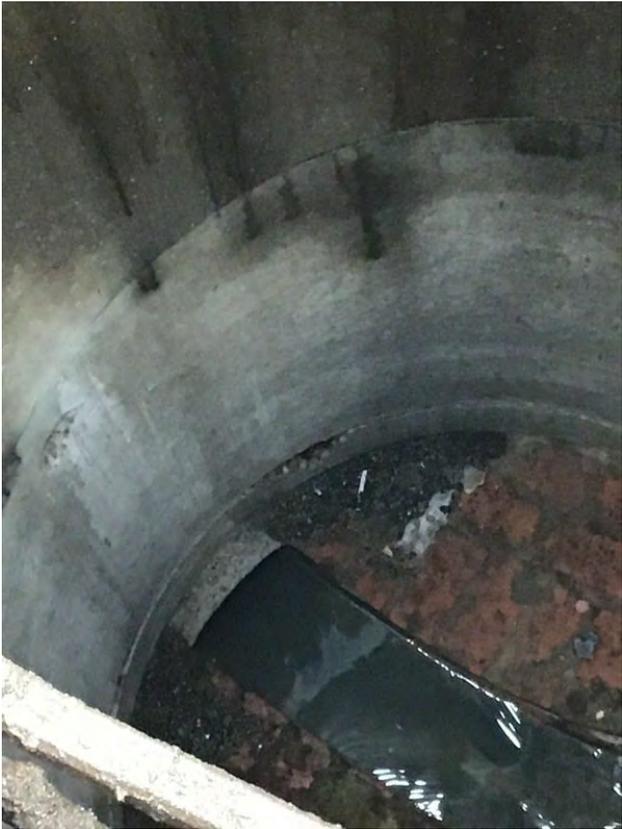
## 14/047

Defect Type	Hole, Void Visible
Location	Wall
Defect Depth Start	12.33
Defect Clock Start	1
Defect Comment	No signs of infiltration
